### DDASaccident396

# DDAS Accident Report

| <b>Where it occurred:</b> MF 1087, OES 4, El Wazzani | <b>Country:</b> Lebanon |

REPORT FOR ACCIDENT INVESTIGATION BOARD OF INQUIRY – No001/2003  
DEMINEING Accident that occurred in OES 4 on 18<sup>th</sup> February 2003 in which [Demining group]  
Deminer Mr. Blessing Mangezi was injured.

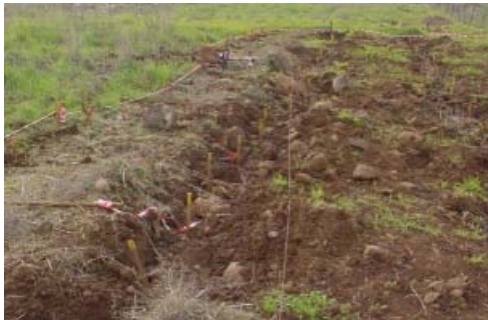
### **VIEW OF THE ACCIDENT SCENE**

- There had been an uncontrolled sub-surface detonation of an Israeli No4 mine.
- [The Victim]'s manual demining probe had been in close proximity to the mine at the time of detonation.
- 15 x Israeli No4 mines had been located and excavated in accordance with the current clearance methodology.
- 1 x Israeli No4 mine had been excavated not in accordance with the current clearance methodology as the top of the mine had been excavated, (last mine excavated prior to the uncontrolled detonation).
- The mine, as detailed above had not been marked with a yellow picket in accordance with [Demining group] SOPs nor National TSGs. (It should be noted that the Investigating Officer marked the mine at the start of the accident investigation).
- The mine row direction had altered and shifted to the right approximately 30cms after the fifteenth mine.

[The row of yellow topped pickets mark where mines were found. The excavation depth is around 10-15cm and there are many rocks.]

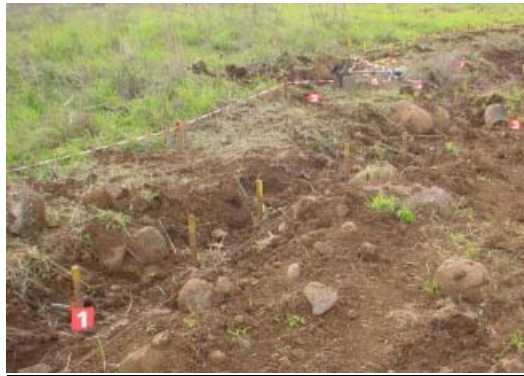
## VIEW OF ACCIDENT SCENE SHOWING NUMBERED EQUIPMENT ITEMS

- No 1 - Manual demining probe.
- No 2 - Base stick.
- No 3 - Visor.
- No4 - Knee protector.
- No 5 - Mine-Lab detector.
- No 6 - Glove left hand.
- No 7 - Glove right hand.
- No 8 - Position of [the Victim] at the time of accident.
- No 9 – Accident seat of detonation.
- No 10 - Rock location following detonation.

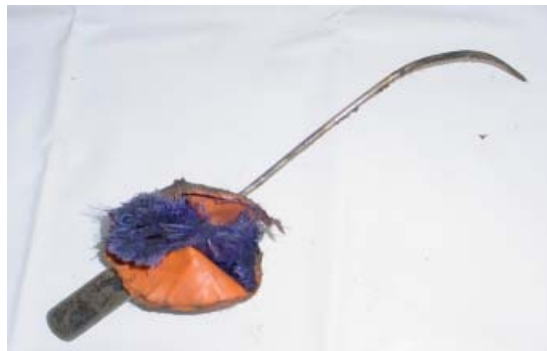
## VIEW OF EQUIPMENT ITEM NO 1 (PROBE)

[The probe is a variant of a blast resistant design developed for safer excavation and probing around AP blast mines. It has bent as designed. Not that the Victim's severe hand injury was with his left hand with which he guided the probe – against the designer's advice.]

- The probe tip (last third of the probe), had been deformed quite considerably through 90°.
- There was evidence of blackening confined to the probe tip.
- There was considerable damage to the Kevlar hand guard.
- The probe had maintained its structural integrity and had not shattered.

- The probe tip had deformed quite considerably because this is the part of the probe that would have been closest to the mine main explosive fill when it detonated.

- The heavy blackening confined to the probe tip is a residual effect of detonating high explosives.
  - The damage sustained to the Kevlar hand guard was due to the blast and fragmentation effects of the mine detonating.

The investigators did not consider the fact that the demining probe was intended to protect the lead hand, but that an error in its use (possibly approved in SOPs) left the guide-hand entirely exposed and far too close to the blast. However, the victim did suffer a broken finger on the right hand – presumably as the probe twisted out of his hand. (The Victim states that he is right-handed in his "statement".)

Damage was occasioned to two items of equipment namely the prodder and the protective visor. The prodder tip was bent by the blast, and the Kevlar hand protector was damaged, it had also been thrown approximately 15m away from where the accident took place.

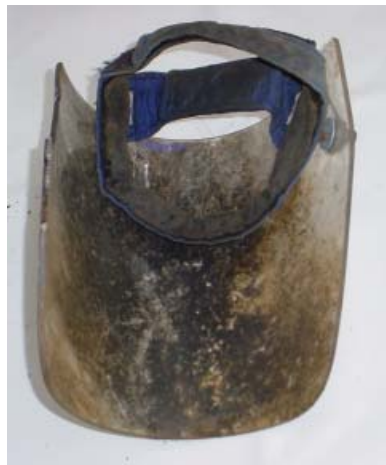
## VIEW OF EQUIPMENT ITEM NO 3 (VISOR)

[The visor shown here has broken around the frame fixing on the left hand side. This is unusual but the fracture is "contained" (not a shatter effect) and is probably due to the visor being twisted sharply as the blast struck. It may have been slightly raised. This visor is designed to withstand AP blast mine detonations at 60cm. If the victim was lying prone in this case, the visor may have been closer to the initiation than its design intent.]

- The vast majority of the blast effects were concentrated on the outer face of the visor.
- There was no part or complete fragmentation penetration of the polycarbonate visor.
- The left hand side visor securing bolt had not maintained its integrity and had broken away.

The visor, which took the brunt of the explosion, was broken on the left side. But the front had maintained its integrity thus saving [the Victim] from serious facial injuries.

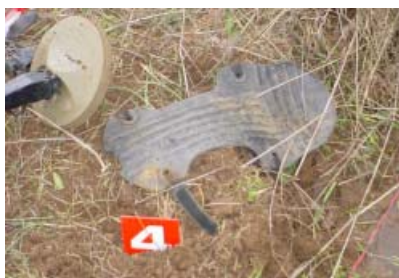
#### VIEW OF EQUIPMENT ITEM NO 4 (KNEE PROTECTOR)

[The “knee-pads” and gloves worn in this accident are not part of demining PPE. Both are designed to provide comfort and protection while carrying out conventional tasks such as gardening. The researcher designed all of the PPE used in this accident, and added these “knee-pads” as a “comfort” extra. The knee-pads have no measured fragmentation resistance. However, limited testing has shown that they do offer some protection against blast.]

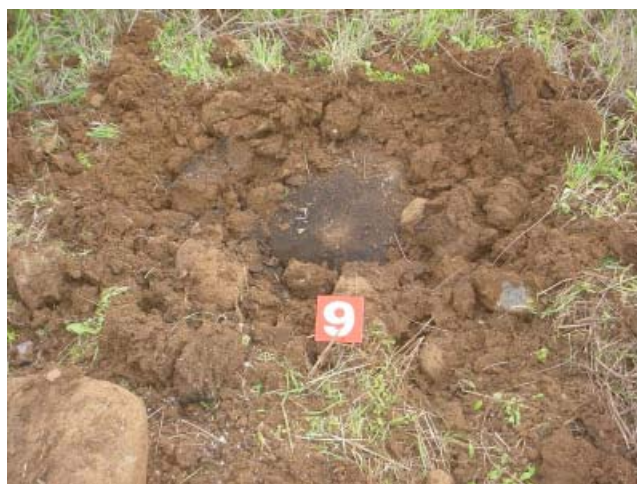
#### VIEW OF NO 9 (SEAT OF DETONATION)

[The rock in the bottom of the crater is scarred, implying that the blast energy may have been reflected making the blast effects worse than they would otherwise have been.]

- The crater had formed through a sub-surface detonation of an Israeli No4 mine.
- A true crater had not formed completely due to the seat of detonation being directly above a large rock. This would have not allowed an absolute and complete 360<sup>0</sup> omni-directional effect of the detonating wave to take place at the time of detonation. Therefore, as opposed to normally having a bulbous shaped crater, the crater sides had broken and were dispersed around the immediate area (spalling effect).
- Immediately at the seat of detonation the rock had fractured and there were 360<sup>0</sup> “splash marks” immediately around the fractured area.
- There was evidence of heavy blackening to pieces of spoil and Israeli No4 mine primary plastic fragmentation was located.
- The lifting effect of the detonating wave had shifted a large rock to the left hand side of the clearance lane.
