DDAS Accident Report

Report date: 28/02/2004	Accident number: 398
Accident time: 07:07	Accident Date: 08/08/2003
Where it occurred: SHA:18, Al Meri, Hasbaya, Nabiatiyah Province	Country: Lebanon
Primary cause: Unavoidable (?)	Secondary cause: Inadequate equipment (?)
Class: Excavation accident	Date of main report: 04/09/2003
ID original source: Bol: 003/2003: SB	Name of source: MACC SL
Organisation: Name removed	
Mine/device: No.4 Israel AP blast	Ground condition:
Date record created: 28/02/2004	Date last modified: 28/02/2004
No of victims: 1	No of documents: 3

REPORT FOR ACCIDENT INVESTIGATION BOARD OF INQUIRY – No 003/2003

DEMINGING Accident that occurred in OES 5 on 8th August 2003 in which [Demining group] Deminer [name excised] was injured.

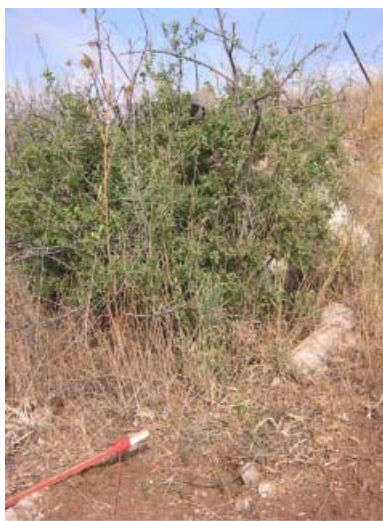
LOCATION OF VISOR

[The visor is in the top of the bush shown here.]

27. The visor was discovered lodged in top of the bush 2-3m from the seat of detonation. On inspection the following were noted:

- The vast majority of blast and fragmentation that hit the visor were absorbed by it.
- There is a 2mm hole slightly left of centre mid way up the visor.
- The polycarbonate has cracked around the left hand visor pivot point.
- Small pieces of hot fragmentation have melted the polycarbonate and have embedded into the outer face.

- f. Visor was breeched on the left side but maintained sufficient integrity as to ensure that no serious facial injuries were sustained to him.
- g. The Kevlar gloves kept their integrity against the mine blast. However the tear/cut in the fabric between the base of the thumb and forefinger and the resulting deep laceration was caused by the blast wave forcing the shoulder of the excavation tool into the hand.

I'm also concerned at the penetration of the ballistic visor. This is the second such incident in-country and if it had not been for the fact that the deminer was wearing additional safety goggles under his visor ([Demining group] SOP) more serious eye injuries would have occurred. I therefore request that [Demining group] seek the manufacturers written confirmation of the blast and fragmentation capabilities of their visor with supporting test results and provide a copy of this report to the MACC SL QA Section.

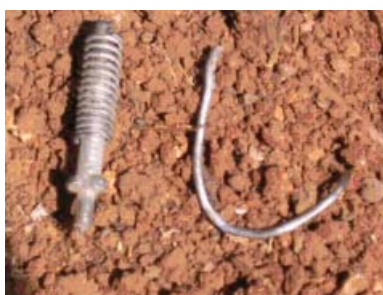
VIEW SHOWING REMAINS OF MUV FUZE STRIKER AND SAFETY PIN RING

21. The inspection and excavation of the accident detonation crater was conducted on 11/08/03 and the following specific observations were noted:

- The crater had formed through a sub-surface detonation of an Israeli No4 mine.
- A striker from an MUV type fuze was located along with the safety pin ring.
- Israeli No4 mine primary plastic fragmentation was located.

45. It is possible that movement of the mine and / or accumulated pressure over a period of time (especially in heavy soil conditions), can also slowly release the yoke and retaining pin. This will therefore reduce the direct pressure required to activate the mine.

- e. [Demining group] are to disseminate to all demining personnel the danger of accumulated pressure on the MUV fuze as fitted to the No 4 AP mine. Prior to the accident there was a train of thought that this fuze could be difficult to activate due to corrosion and [Demining group] introduced a neutralization method for use where necessary. The accident itself and **unreported** sympathetic detonations on SHA 18 indicate that fuze can be as sensitive as a No 9 igniter.

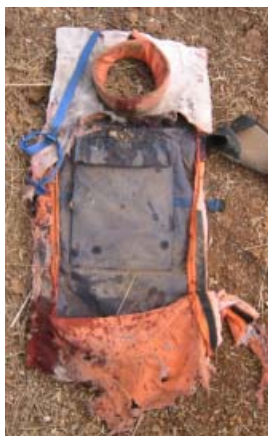
VIEW OF [Victim]'S PROTECTIVE VEST

- The outer cover was ripped from the top downwards
- The blast debris was concentrated in the upper third slightly right of centre
- There was part fragmentation penetration of the Kevlar lining.
- Neck guard was intact
- The breast plate was broken diagonally however there was no fragmentation penetration into the vest behind it.

[The torn cotton outer has been peeled back to reveal the ballistic aramid (NOT Kevlar) inner with a pocket containing a sheet of 5mm polycarbonate to raise the protection level over the chest. The polycarbonate insert had snapped in half.]

- e. He was correctly wearing his full complement of PPE as per [Demining group]'s SOP. (Safety goggle frames were uncovered in the uncleared area on 14/08/03) The good quality of the PPE has undoubtedly saved [the Victim] from very serious injury. The protective jacket maintained its integrity.

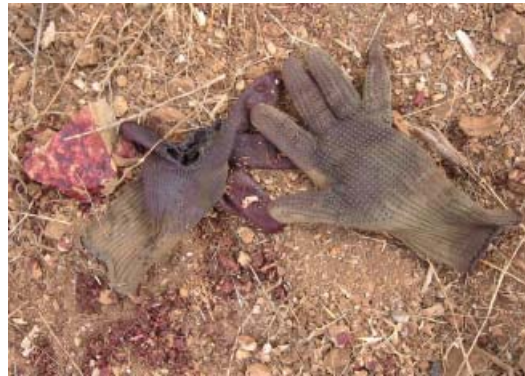
29. The medical staff removed the gloves during stabilization. They were inspected and the following points were noted:

- The left hand glove did not suffer any damage
- The right hand glove has been generally retained its integrity against the blast and fragmentation. However it was cut severely in the area between the base of the thumb and the forefinger where the excavation tool was gripped.

[The gloves are shown above.]

- c. Leather gauntlets should not to be worn on top of protective working gloves when conducting excavation and prodding drills. [Demining group] are to state in the company SOPs the criteria for wearing leather gauntlets.

- Correcting errors/faults
 - Detector testing
 - Marking systems.
 - Site and team preparation
 - Task appreciation and lane placement.
- g. [Demining group] should consider replacing their current excavation trowel with one that will cause less damage to a deminers hand should there be an accident in the future. (Refer to Reference F)
