DDAS Accident Report

Report date: 06/03/2004	Accident number: 402
Accident time: 11:25	Accident Date: 20/07/2001
Where it occurred: MNB West, Rasa Koshare: Dossier W02-37, MF 305	Country: Kosovo
Primary cause: Inadequate survey (?)	Secondary cause: Management/control inadequacy (?)
Class: Missed-mine accident	Date of main report: 26/07/2001
ID original source: Bol: 009/2001: TKG	Name of source: KMACC
Organisation: Name removed	
Mine/device: PMA-2 AP blast	Ground condition: woodland rocks/stones
Date record created: 05/03/2004	Date last modified: 05/03/2004
No of victims: 2	No of documents: 1

REPORT FOR ACCIDENT INVESTIGATION BOARD OF INQUIRY – No 009/2001

Mine Accident that occurred in MNB West on Friday 20 July 2001 in which [Demining group] Section Leader [The Victim] was injured.

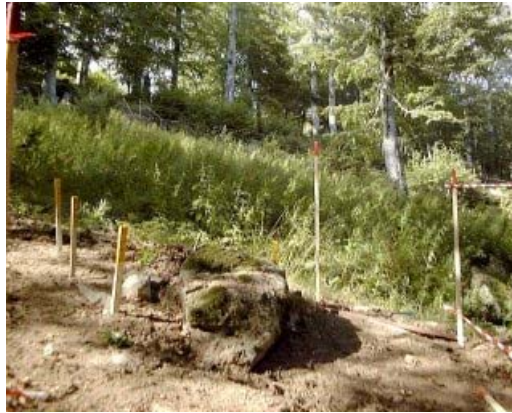
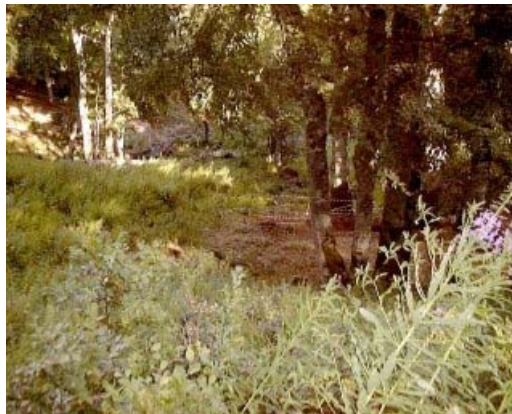
VIEWS OF ACCIDENT SITE

3. This finding is based on the fact that at the time of the accident the Section Leader [the Victim] was walking in a manually cleared area conducting her duties as Section Leader. The manual clearance of this lane had been cleared according to [Demining group] clearance procedures and also in accordance with the [Demining group] Threat Assessment for this minefield, which is excavation to a depth of 5cm. This mine was at a depth of 16cm. This minefield is nearing completion and all previous blast mines found in this minefield have been located within this depth of 5cm.

- All blast mines located in this minefield (over 100 to date) have been within the excavated depth of 5 cm.
 - This mine was not located during the excavation drill as it was at a depth of 16cm.

- The clearance depth for the Rasha Koshare minefields are to be amended to take into consideration the depth of this mine that has been proven to be greater than 5cm.
- [Demining group] are not to commence clearance operations until the MACC QA Officer has ratified the amended clearance depth.

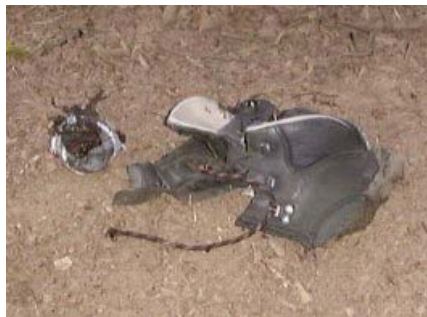
VICTIM'S RIGHT BOOT

19. [The Victim] has had her right foot amputated. She also suffered minor injury to her right hand as a result of the blast. She has a slight injury to her right eye, which was caused by her helmet when she fell to the ground after the explosion. Annex E details the medical report from the MACC QA Medical Officer.
