DDASaccident403

DDAS Accident Report

Report date: 10/03/2004	Accident number: 403
Accident time: 09:12	Accident Date: 05/03/2001
Where it occurred: Veli village, municipality Berkovii, Nr Stolac	Country: Bosnia Herzegovina
Primary cause: Field control inadequacy (?)	Secondary cause: Management/control inadequacy (?)
Class: Missed-mine accident	Date of main report: 09/03/2002
ID original source: VMM, RB	Name of source: RS MAC BiH
Organisation: Name removed	
Mine/device: PROM-1 AP Bfrag	Ground condition: rocks/stones grass/grazing area
Date record created: 06/03/2004	Date last modified: 09/03/2004
No of victims: 1	No of documents: 1

BOARD OF INQUIRY REPORT - DEMINING ACCIDENT MARCH 5th 2001 March 9th 2001.

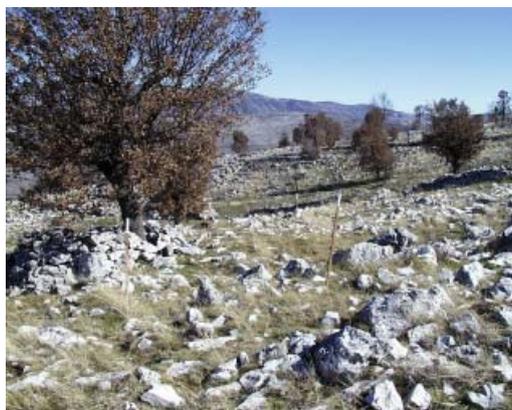
12. Task site layout with all the administrative areas is set according to the BH Standard. Access lane leading between the administrative areas and the datum line is marked with 1.2 m white tipped pickets with no tape attached (access lane through cleared / safe area). The place in the working lane that was reached the previous day is marked with crossed 0.5m white tipped pickets. This marking is in accordance with [Demining group] SOP but not with the BH Standard.

[The picture shows the mined area being worked on.]

59. The access lane marking and the points of progress within the working lane are to be marked in compliance to the BH Standard.

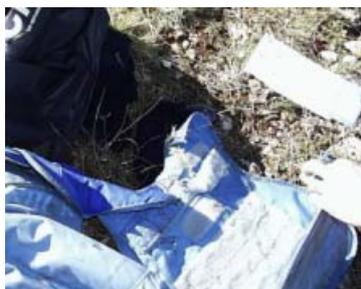
34. The protective jacket shows transparent holes at the upper chest part as well as at the left neck protection part. Crotch protection also contains visible shrapnel holes. (Photographs shown in Annex C).

[The picture shows some damage to the neck of the Victim's armour apron.]

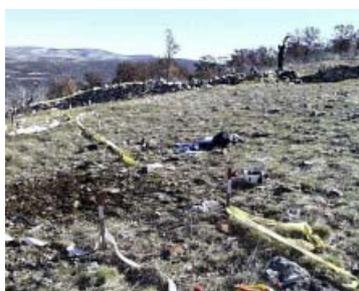
37. The injured deminer stepped on a PROM-1P mine at about 3.60m from the beginning of his lane, which indicates that he had 'cleared' about 4 square metres since he started to work.

[The picture shows the accident site. Photographs showing the victim's boot and what appear to be bits of the victim's leg were also made available.]

45. Mine was activated by pressing the left foot on the PROM-1P mine fuse. The mine activated just above the ground level. The position of the leg torn by the explosion indicates that the mine exploded right behind the left leg (left boot damaged). The body was in the position for flushing the pickets into the ground (left hand holding the picket – 2nd and 3rd finger of the left hand amputated, while the hammer was in his right hand), which is indicated by the reports of both the medic and the doctor at the emergency hospital in Trebinje. In the moment of explosion, the base stick was placed in front of the deminer (in front of the mine that exploded – while the mine remained in the cleared area) at probably at the left leg boot. The location of where the base stick parts were found as well as the leg torn by the explosion stands for this fact.

46. All these facts indicate that the deminer was in front of the mine with both his feet and that the mine was skipped.

53. It is very often that the breach of procedures leads into an accident. Metal detector should be used in two sweeps over the ground without touching it, progressing for the half of the halo head.

54. Working lane marking is to be conducting during the searching procedures. The base stick is the border between the searched and unsafe area and is to be moved forward onto the area that is searched in accordance with the procedures. After two metres of search, short picket is flushed inside the searched area (the overlap).
