### DDASaccident405

# DDAS Accident Report

<b>Report date:</b> 27/03/2004	<b>Accident number:</b> 405
<b>Accident time:</b> 08:20	<b>Accident Date:</b> 19/08/2001
<b>Where it occurred:</b> Bregana Dubrovnik Highway, Near Urije. Licko-Senjaska, Licki Osic	<b>Country:</b> Croatia
<b>Primary cause:</b> Field control inadequacy (?)	<b>Secondary cause:</b> Management/control inadequacy (?)
<b>Class:</b> Missed-mine accident	<b>Date of main report:</b> 17/09/2001
<b>ID original source:</b> NO/ML	<b>Name of source:</b> CROMAC
<b>Organisation:</b> Name removed	
<b>Mine/device:</b> PMA-2 AP blast	<b>Ground condition:</b> leaf litter metal scrap route (verge) woodland (bush)
<b>Date record created:</b> 24/03/2004	<b>Date last modified:</b> 27/03/2004
<b>No of victims:</b> 1	<b>No of documents:</b> 1

Accident Report on a Project demining a “Section of the Highway Bregana Dubrovnik (Section III B2, Licki Osik – Sv. Rok) – area of Urije – phase 2” involving the company [Demining group]. The clearance project identification code was: LSLO-SB-ICH-198-07-00

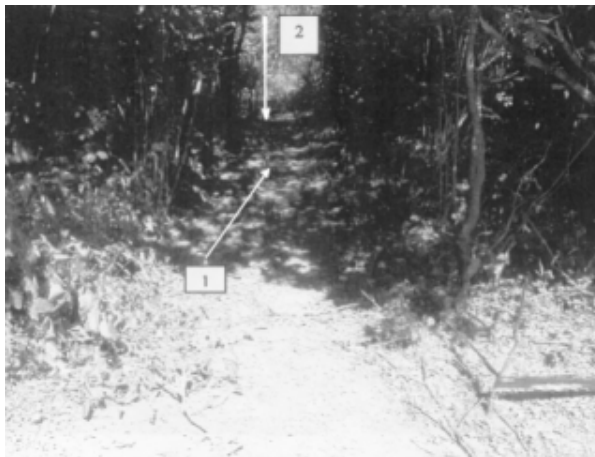
[The picture shows the lane approaching the accident site with the position of the PMR-2A mines indicated.]
