DDAS Accident Report

Report date: 22/05/2004	Accident number: 406
Accident time: 05:55	Accident Date: 23/11/02
Where it occurred: Task No.116, Kamchewai, Northern Red Sea Zone	Country: Eritrea
Primary cause: Inadequate training (?)	Secondary cause: Management/control inadequacy (?)
Class: Missed-mine accident	Date of main report: 07/12/2002
ID original source: AM HT	Name of source: MACC Eritrea
Organisation: Name removed	
Mine/device: AT (unrecorded)	Ground condition: dry/dusty grass/grazing area
Date record created: 01/04/04	Date last modified: 22/05/04
No of victims: 8	No of documents: 2

FATAL INCIDENT REPORT, DEMINING INCIDENT AT KAMCHEWAY 23 NOVEMBER 2002 - AN ANTI TANK (AT) MINE MISSED BY THE MINE DETECTION DOG (MDD) TEAM

Demining Incident Preliminary Investigation Report for Submission to the Director of the [Demining group] and the Eritrean Demining Authority

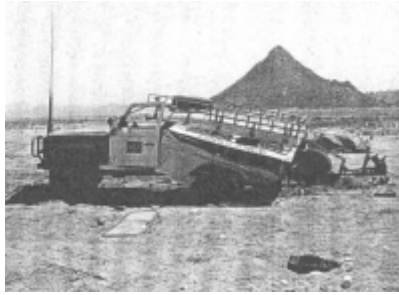
The team then entered the minefield from the access route and along the main breach lane passing Administration/parking areas 1 and 2. It was evident from area 1 that the accident had occurred in a cleared area.

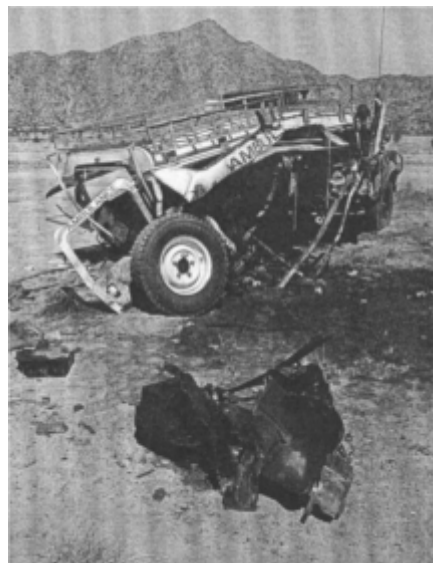
After studying the minefield maps which had been carried to, and retrieved from the scene it was possible to identify that the detonation had taken place within an area cleared by Manual deminers and Mine Detection Dogs (MDDs).

The following marking was located; 1.5 metre metal picket (with yellow sign attached) indicating the position of an AT detonation that occurred in December 2001 killing a child, perimeter turning point 101 marked during remapping in November 2002, black and white stones indicating the location of three (2 metre x 2 metre) boxes of Manual Quality Assurance performed on a lane of MDD clearance (QA No's 64, 65 & 66). The following measurements were then recorded:

Depth of crater: - 0.65 metres
 Diameter of crater: 2.40 metres

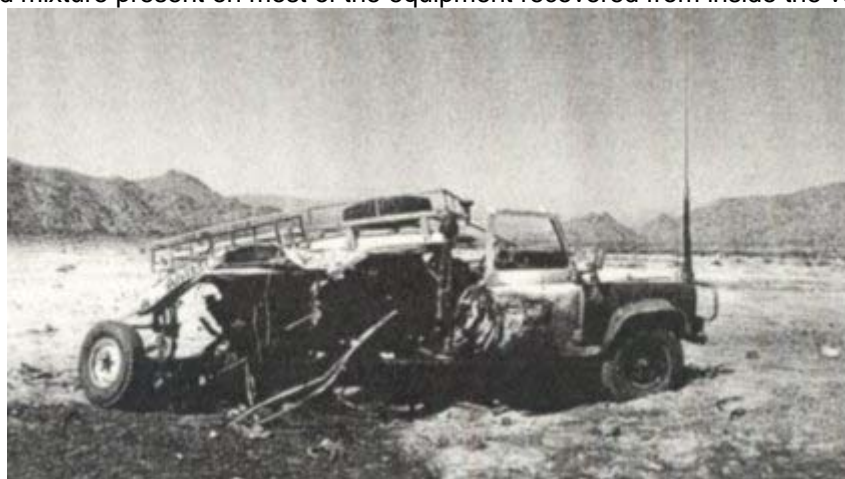
Damage to Vehicle and Equipment

The rear right wheel of the Landrover 110 Ambulance detonated the AT mine. The vehicle was thrown through 180° coming to rest facing back in the direction it had come. The rear right wheel was completely destroyed, the axle had been forced upwards through an angle of more than 45°, the floor of the rear of the vehicle had been forced through a similar angle. The entire right hand side of the vehicle from the back door to the cab had been destroyed. The vehicle had buckled approx. midway along the chassis causing the roof above the cab to fold up and back. Team equipment such as detectors, tool bags, and marking rope reels that were being carried on the roof of the vehicle were thrown clear. The trauma bag (used by the medic at the scene) was recovered intact from the rear of the vehicle. Vests and visors removed from the interior of the vehicle were covered in a mixture of diesel and mud, some of the visors had broken headbands and fogged fronts. The demolition exploder case had been partially damaged and the exploder itself had shattered. The detonator boxes carried inside the detonator compartment built into the rear left frame of the vehicle (situated under the rear most seat on the left) were undamaged as was the compartment itself. The explosives box carried inside the rear of the vehicle was dented but otherwise intact. The second stretcher (orange, vinyl) also carried inside the vehicle was badly damaged and coated in the same diesel, mud mixture present on most of the equipment recovered from inside the vehicle.

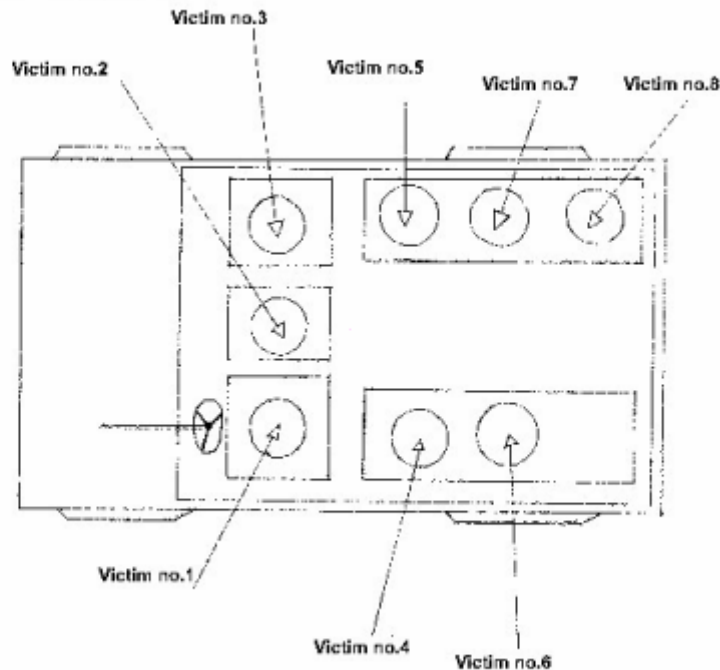
[Seating plan of vehicle – from an annex]

Eight people were travelling in the vehicle at the time of the accident. Three passengers died at the scene, one died on route to hospital, two were admitted to hospitals in Keren the remaining passengers were x-rayed at Keren Hospital and then sent to Asmara.
