DDASaccident413

DDAS Accident Report

Report date: 06/07/2005	Accident number: 413
Accident time: 10:15	Accident Date: 27/06/2004
Where it occurred: Puliyankulam village, Vavuniya District, Vanni	Country: Sri Lanka
Primary cause: Inadequate equipment (?)	Secondary cause: Field control inadequacy (?)
Class: Other	Date of main report: 28/06/2004
ID original source: KS	Name of source: LA
Organisation: Name removed	
Mine/device: P4Mk1 AP blast boosted	Ground condition: grass/grazing area hard
Date record created: 06/07/2005	Date last modified: 06/07/2005
No of victims: 0	No of documents: 2

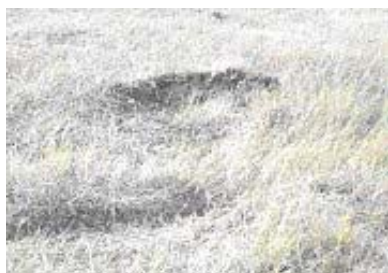
The tyre of the tanker was damaged when it ran over a PK-Mk4 AP mine “attached to a 60mm mortar”.

[The blast crater left by the device is shown above.]

The primary cause of this accident is listed as *“Inadequate equipment”* because the water bowser used was too big to be safely manoeuvred inside the mined area. It had been unable to turn without using the uncleared area on a previous occasion and the driver had been instructed to use the uncleared area. The instruction to use an uncleared area for vehicle turning is the reason that the secondary cause of the accident is listed as a *“Field control inadequacy”*. The field supervisors could have ordered areas close to the bund to be cleared so that the vehicle could manoeuvre on cleared land, but did not do so.

The demining group involved developed a Safe-lane water bowser capable of moving inside 2 metre wide lanes and reversing along them during 2005.

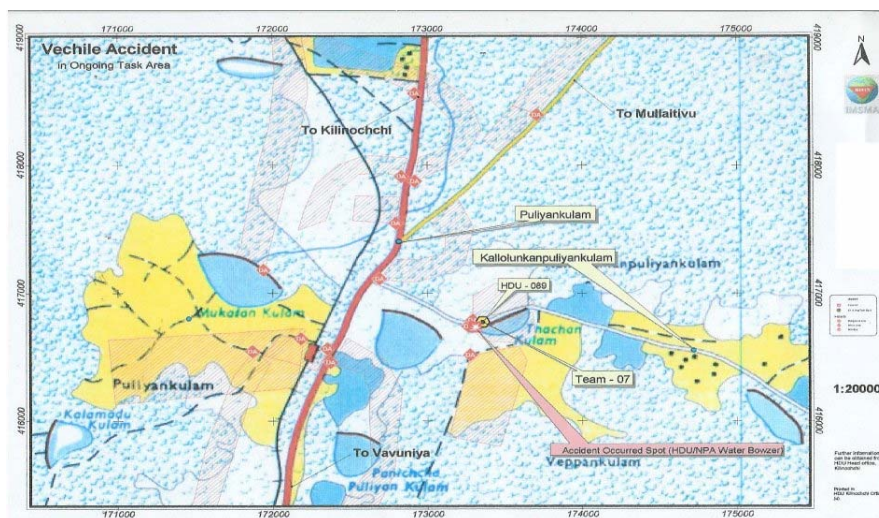
A map of the accident area is shown below.
