# DDASaccident414

# DDAS Accident Report

<b>Report date:</b> 06/07/2005	<b>Accident number:</b> 414
<b>Accident time:</b> 10:04	<b>Accident Date:</b> 24/08/2004
<b>Where it occurred:</b> Erlalai, Nr Punnalaikadduwan, Valikamam South, Jaffna	<b>Country:</b> Sri Lanka
<b>Primary cause:</b> Field control inadequacy (?)	<b>Secondary cause:</b> Inadequate training (?)
<b>Class:</b> Excavation accident	<b>Date of main report:</b> 25/08/2004
<b>ID original source:</b> SP	<b>Name of source:</b> SP
<b>Organisation:</b> Name removed	
<b>Mine/device:</b> P4Mk2 P4Mk1 AP blast	<b>Ground condition:</b> hidden root mat rocks/stones woodland
<b>Date record created:</b> 06/07/2005	<b>Date last modified:</b> 06/07/2005
<b>No of victims:</b> 1	<b>No of documents:</b> 1

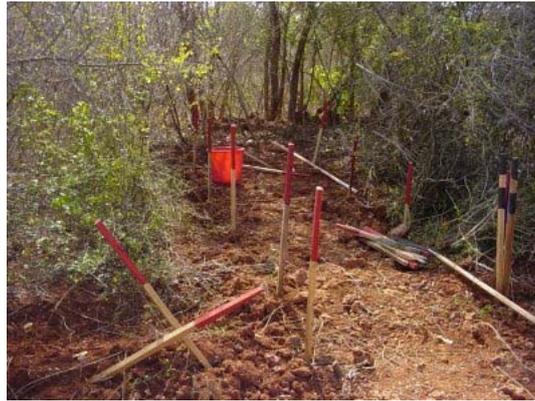
“Description: Accident spot terrain type is rocky red clay with heavy vegetation.”

[The picture above shows the accident lane.]

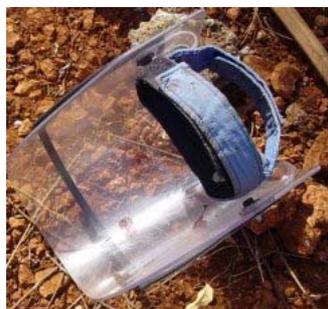
[The picture above shows the Victim's visor with blood spots on the inside.]

“Paramedic comes to spot one minute later, gives first aid, notices a small bleeding wound in deminer’s left cheek and three small bruises in the left arm. Small stone has hit the deminer in the face, entering between fragmentation vest collar (body protection) and bottom of visor (head protection).

The primary cause of this accident is listed as a "*Field control inadequacy*" because the victim was working with his visor raised and his error was not corrected. The secondary cause is listed as "*Inadequate training*" because the internal investigator noted "lessons learned" that were basic training requirements in the rake-drill.

- 1) Wearing protective equipment in a correct manner, leaving not open entrance between body protection collar and head protection visor.
- 2) Using heavy rake clearance method between two roots, where rake cannot be pulled freely, makes little sense. Instead, prodder is to be used always when a spot is a difficult one to check. After that cutting the roots with pruner, before advancing to heavy rake method.

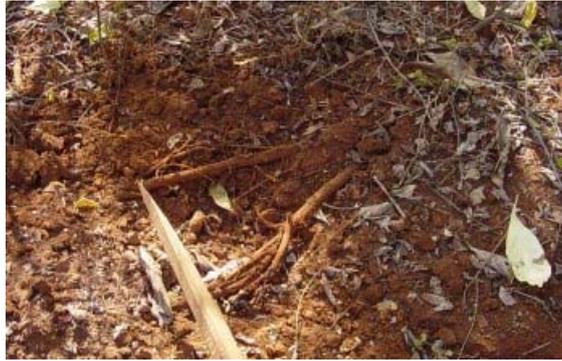
“Experienced deminer **sets up an antipersonnel mine with his heavy rake**. There are two one inch thick bush roots lying horizontally in depth of four centimetres, twenty five centimetres from each other. Antipersonnel mine was situated between the roots. Instead of prodding the spot between the roots, deminer continued raking with heavy rake.

[The picture above shows the roots in the blast crater with the broken handle of the rake pointing inwards.]
