# DDASaccident416

Humanitarian Demining Accident and Incident Database  
*AID*

# DDAS Accident Report

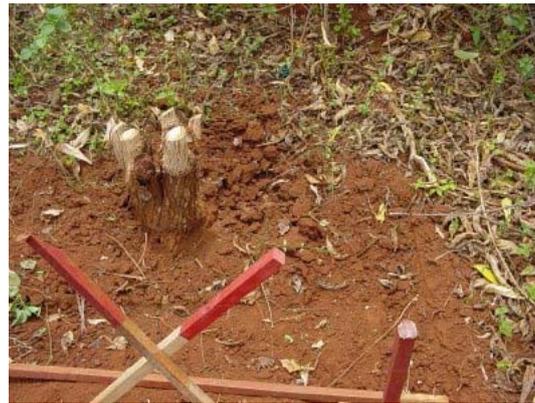
“Incident spot terrain is hard, red clay type soil with vegetation. Soil is softened before raking by moisturizing it with plenty of water. Antipersonnel mine was situated in a clear clay spot without rocks and partly surrounded by approximately 5 year old tree. There were not disturbing objects around.

[The picture above shows the accident site with the small crater alongside the stumps of a small tree.]

“Shape of the explosion crater is small 30 cm x 30 cm x 15 cm and perfectly round shaped, which slightly leads to a conclusion that P4 was laid in normal horizontal (pressure plate upwards) position. It is possible, that P4 was damaged and missing parts of its pressure plate and therefore more sensitive.”

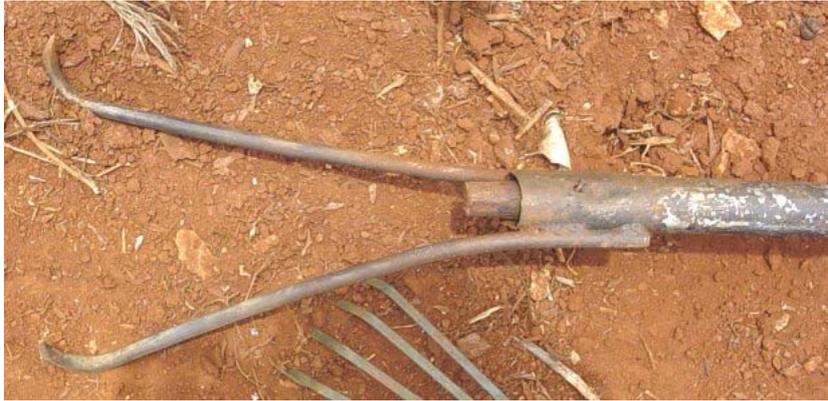
[The picture of the damaged rake shown above is of an SOP approved 2-tine rake. The tines appear worn so that they do not “hook” as shown in the group’s SOPs, but this may have been caused by the blast. The tines have been splayed by the blast.]

The primary and secondary cause of this accident are listed as “*Unavoidable*” because it seems likely that the deminer was working as directed to approved SOPs when the initiation occurred. It is possible that the rake tines were worn and misshapen, but this may have occurred in the blast.
