DDASaccident417

DDAS Accident Report

Report date: 09/07/2005	Accident number: 417
Accident time: 08:40	Accident Date: 08/07/2004
Where it occurred: Periya Pullumalai, Batticaloa	Country: Sri Lanka
Primary cause: Field control inadequacy (?)	Secondary cause: Victim inattention (?)
Class: Excavation accident	Date of main report: 21/07/2004
ID original source: SL-10	Name of source: MH
Organisation: Name removed	
Mine/device: P2Mk2 P4Mk1 AP blast	Ground condition: grass/grazing area soft
Date record created: 09/07/2005	Date last modified: 09/07/2005
No of victims: 1	No of documents: 3

Reference: Accident Investigation & BOI, 8th July 2004, minefield site at Periya Pullumalai, Batticaloa

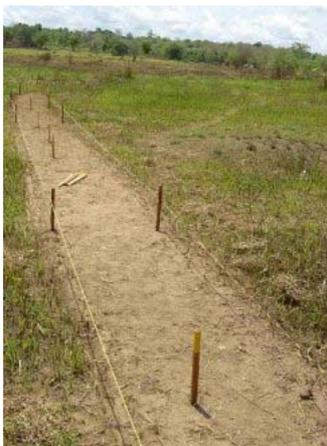
The site is on open ground with medium to long grass with some areas of dense undergrowth and sporadic bushes and trees. The site of the accident was medium length grass with no undergrowth. The site is on a slight rise on the Southern side of the site. See Annex E-1 "Site Sketch Map". The ground consists of loam fertile soil, with a soft to medium/hard density depending on the moisture content of the soil.

[The photograph above shows the accident lane with yellow pickets marking where mines had previously been found.]

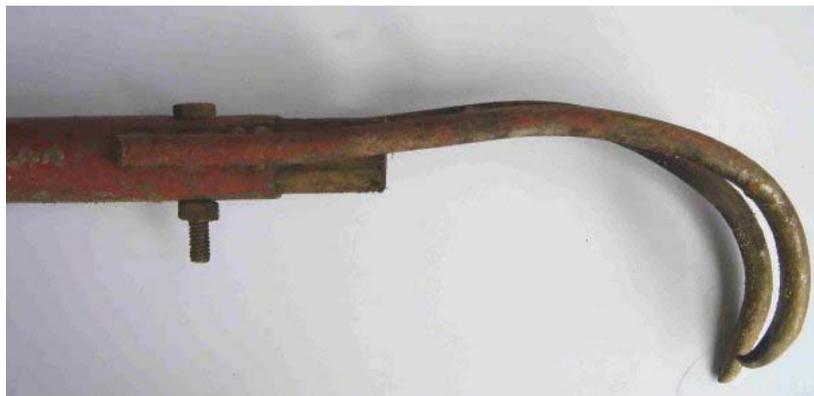
The only damage to equipment was very slight blast damage to the point of one prong of the heavy rake and damage to the inside of the visor.

[Damage to the head of the rake is shown above.]

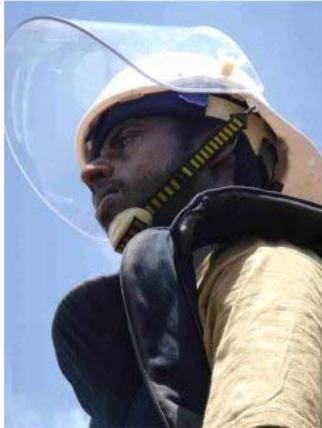
The damage and blast marks to the visor could only have accrued if the visor was up at the time of the explosion. [Damage included blast mark on the inside of the visor and on the front of its supporting plastic helmet.]

Although the deminer, [the Victim], was wearing the required PPE in accordance with his organisations SOPs, his visor was up at the time of the explosion. This breach of SOPs led directly to the injuries to his face, which would have otherwise been prevented.

[The Demining group took the picture above to illustrate the position of the visor at the time of the accident. Note that the plastic hat is not PPE and is not recorded as a “helmet” under PPE.]

[The Demining group] should conduct short refresher training to highlight the issues raised in this report and to reinforce the importance of following the agencies SOPs.

The agencies involved should consider taking appropriate discipline action against the deminer, as they deem fit.
