DDASaccident418

DDAS Accident Report

Report date: 19/05/2006	Accident number: 418
Accident time: 15:30	Accident Date: 08/10/2003
Where it occurred: Malvil Village, Pallai region, Kilinochi District	Country: Sri Lanka
Primary cause: Inadequate survey (?)	Secondary cause: Inadequate equipment (?)
Class: Missed-mine accident	Date of main report: 10/10/2003
ID original source: TG/RS	Name of source: LA
Organisation: Name removed	
Mine/device: M15 AT blast	Ground condition: hard route (verge)
Date record created: 21/07/2005	Date last modified: 21/07/2005
No of victims: 3	No of documents: 2

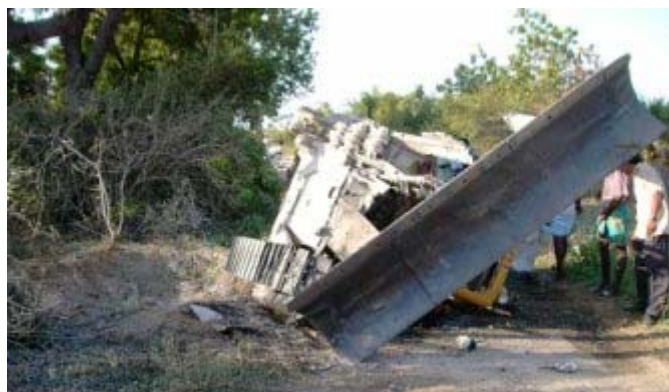
“A bulldozer and crew contracted by the GA and managed by the AGA was working in Malvil on the day of the incident. [Victim No.1], Bulldozer driver, [Victim No.2], Driver’s Assistant and [Victim No.3], AGA appointed foreman were tasked with levelling the SLA bunds and clearing excess vegetation around the village. Immediately prior to the incident the bulldozer was on the dirt road running through the village and attempting to turn around. As the bulldozer moved off the road in its attempt to turn, an explosion occurred under the right hand track, tipping the bulldozer over and throwing the three contractors away from the site.

[The picture above shows the bulldozer after the accident.]

“It is apparent that the direct pressure from the bulldozer activated a metallic anti-tank mine, while driving off the edge of a well used road. The mine appears to have been an M-15 anti-tank mine laid by the SLA as part of their defences in Malvil Village.

“Risk assessments conducted prior to mine clearance activities should include a consideration of anti-tank mines in the task area.

“Additionally, an electronic means of efficiently locating anti-tank mines should be considered to enhance the capability of [Demining group] deminers in the Vanni.”
