DDASaccident418

DDAS Accident Report

Report date: 19/05/2006	Accident number: 418
Accident time: 15:30	Accident Date: 08/10/2003
Where it occurred: Malvil Village, Pallai region, Kilinochi District	Country: Sri Lanka
Primary cause: Inadequate survey (?)	Secondary cause: Inadequate equipment (?)
Class: Missed-mine accident	Date of main report: 10/10/2003
ID original source: TG/RS	Name of source: LA
Organisation: Name removed	
Mine/device: M15 AT blast	Ground condition: hard route (verge)
Date record created: 21/07/2005	Date last modified: 21/07/2005
No of victims: 3	No of documents: 2

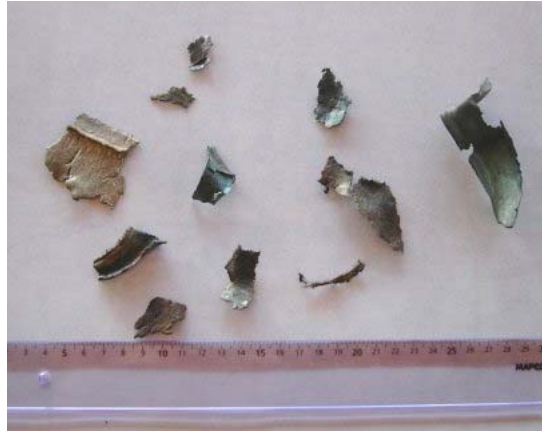
“Thin metal fragments were found in the crater left by the explosion. These fragments are consistent with that of an M-15 anti tank mine commonly used by the SLA.

[The picture above shows the recovered fragments.]
