### DDASaccident420

# DDAS Accident Report

<b>Report date:</b> 21/07/2005	<b>Accident number:</b> 420
<b>Accident time:</b> 08:30	<b>Accident Date:</b> 28/11/2001
<b>Where it occurred:</b> Cabina Vermelha road, 22 km SW of Ndatatando city, Kuanza North Province	<b>Country:</b> Angola
<b>Primary cause:</b> Field control inadequacy (?)	<b>Secondary cause:</b> Unavoidable (?)
<b>Class:</b> Missed-mine accident	<b>Date of main report:</b> 20/04/2005
<b>ID original source:</b>	<b>Name of source:</b> NPA
<b>Organisation:</b> Name removed	
<b>Mine/device:</b> MAI-75 AP blast	<b>Ground condition:</b> route/path wet
<b>Date record created:</b> 21/07/2005	<b>Date last modified:</b> 21/07/2005
<b>No of victims:</b> 1	<b>No of documents:</b> 1

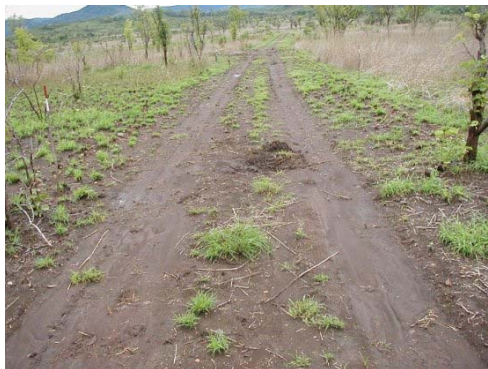
There were some rumours about remining but there were not strong evidences of remining. It seemed to be an old mine buried in the middle of the road that a deminer left in the cleared area probably due to a mistake or technical problems with metal detector.

Probably, this accident did not happen before because the ground was very hard and the mine was buried in approximately 15 cm deep in the middle of the road. People have been using this area normally. Due to the rain, the ground became less hard and slippery. The vehicle escaped approximately 30 cm from the usual track and it drove over the mine for the first time causing the accident.

The accident site. The AP mine was buried in the middle of the path.
