# DDASaccident421

# DDAS Accident Report

<b>Report date:</b> 26/07/2005	<b>Accident number:</b> 421
<b>Accident time:</b> 09:00	<b>Accident Date:</b> 21/09/2003
<b>Where it occurred:</b> Cambondo road, 2k km from Cambaixe, Malanje Province	<b>Country:</b> Angola
<b>Primary cause:</b> Victim inattention (?)	<b>Secondary cause:</b> Inadequate survey (?)
<b>Class:</b> Victim inattention	<b>Date of main report:</b> 21/07/2005
<b>ID original source:</b> JES/AVS	<b>Name of source:</b> JES
<b>Organisation:</b> Name removed	
<b>Mine/device:</b> TM57 AT blast	<b>Ground condition:</b> route (verge)
<b>Date record created:</b> 22/07/2005	<b>Date last modified:</b> 26/07/2005
<b>No of victims:</b> 8	<b>No of documents:</b> 1

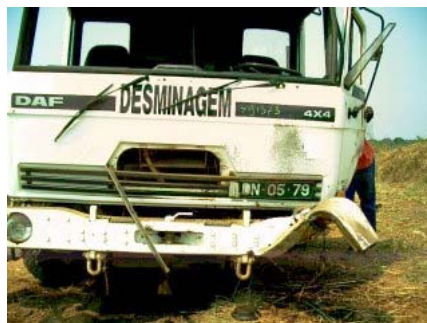
The accident happened 21 September 2003. The truck was carrying deminers to work along the cleared section of the road. At 09:00 in the morning, the truck crossed into the uncleared area by a short distance and its left side front wheel detonated a TM-57 AT mine.

The picture shows the front of the damaged truck.

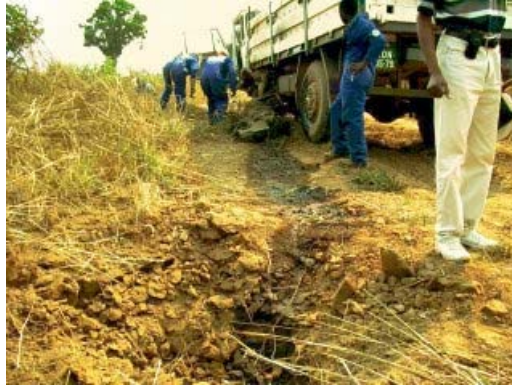
The investigator found that the driver had been travelling too fast and had veered onto the uncleared area, detonating the mine 8 cm from the edge of the safe track.

The picture shows the crater in the foreground and the damaged truck beyond. The detonation removed the wheel and damaged the wheel hub and track-rod. The front bumper, wheel-arch, cab door, steering wheel and internal fittings were damaged.

The driver did not follow his SOP with regard to driving at an appropriate speed to ensure that the vehicle did not leave the cleared area. The pre-survey had yielded unreliable information, probably due to the relative inexperience of the base survey team.

Immediate revision of SOP procedures for road clearance tasks to stress the to drive only on cleared' areas.

Establishing a QA control for drivers to ensure that they keep to SOPs.

Refresher-training followed by closer follow up of the base survey team.
