### DDASaccident426

# DDAS Accident Report

## **PRELIMINARY INVESTIGATION REPORT**

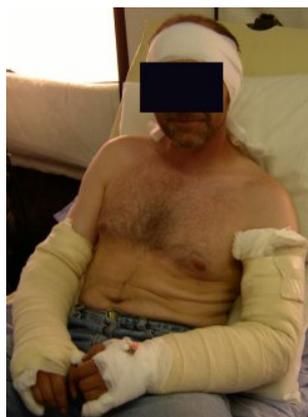
A full medical report from the British Military Hospital at Shaibe Airfield (near Basrah) southern Iraq is held on record. The medial report gives the victim's date of birth as 14/08/1965. He was treated for "5% burns, largely partial thickness" caused by "artillery propellant due to static explosion at approx 11 am".

Burns (1) Probably partial thickness from above to below elbow and down to wrists, ventral aspects with some blisteriong, both forearms.

(2) Back of neck with some blisteriong. Probably partial thickness.

(3) Behind both ears and tips of pinnas R and L - possibly subdermal full thickness.

The photograph below shows the extent of the victim's injuries.
