DDASaccident427

DDAS Accident Report

Report date: 31/07/2006	Accident number: 427
Accident time: 07:50	Accident Date: 26/06/2003
Where it occurred: Talaimannar Pier, Mannar district	Country: Sri Lanka
Primary cause: Unavoidable (?)	Secondary cause: Inadequate equipment (?)
Class: Missed-mine accident	Date of main report: 12/08/2003
ID original source: MAN/03/001	Name of source: [Name removed]
Organisation: [Name removed]	
Mine/device: Type 72 AP blast	Ground condition: dry/dusty metal fragments sandy
Date record created: 29/07/2006	Date last modified: 31/07/2006
No of victims: 1	No of documents: 4

Preliminary Investigation Report

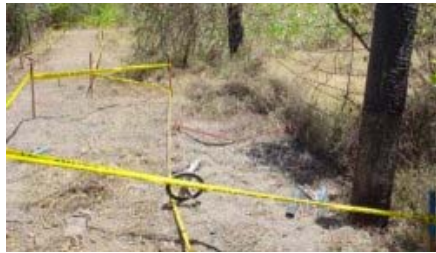
According to the deminer statement He has cleared the line about 1 m to 1,5 meter and made search for signal in one location he got more signals and have made a deep hole to try to located the signals when he was satisfy with the investigation of the hole he has moved his base stick and got up from his knee position to take the gardening shear in order to cut side vegetation at that time his left leg twisted skid towards in the previous excavation hole . Immediately he heard some noise and sand and dust all over his body the smoke also coming from the direction and he fell down. Prior to the explosion, the casualty had been getting multiple signals from the large amount of disintegrating barbed wire in the area. He was confused by the large number of signals and failed to investigate all of them, believing then to be barbed wire fragments.

[A picture of the accident site is shown above.]

l) The area where the deminer was working in a heavily metal contaminated area, (adjacent to rusting barbed wire exposed to salt sea air for the last ten years) the signals from the mine detector may have confused the deminer.

a) Detectors will not be used in the heavily metal contaminated area like between old rusty barbed wire fence. These areas should be cleared using excavation methods down to a minimum depth of 15cms.

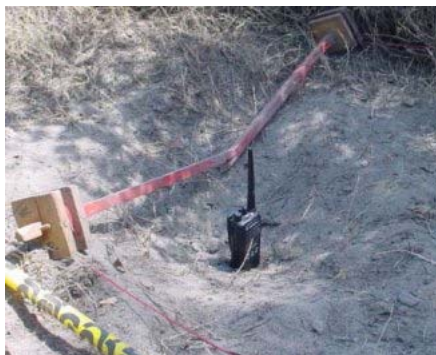
The accident crater was approximately 15 cm behind to the base stick, and ground checked by the deminer. It has a depth of 19cm and a diameter of 54 cm.

[A picture of the crater is shown above.]

This indicates that the mine was buried more than 13 cm below the surface. The centre of the crater was 75cm from an existing barbed wire fence. Excavation of the crater revealed fragments of a China Type 72 antipersonnel blast mine (see device technical report on Annex g).

The mine was activated by the inside of the deminer's left heel. The sole of the boot sustained no damage. I surmise that the deminer may have stood on the side of his investigation hole and pushed the very loose sand onto a mine. This sand initiated the mine and also provided a buffer from the effect of the blast lessening the potential injury .

a) Close to the accident site an old bakery was establish some year ago all the ashes resulting the use of the oven of the bakery was sprayed all around for many year mixing with the original sand. The crater caused by the detonation was 19 cm deep, suggesting that the mine was buried at a depth greater than the 13cm recommended by [Demining group] SOP Sri Lanka .Since the team began working on this task on 19th February 2003 they had removed 986 Chinese Type 72A, 107 Pakistani P4s and 9 Claymore type mines by 20th June. Except for the mine involved in the accident, all other mines were surface laid or were laid within 5 cm under the surface.

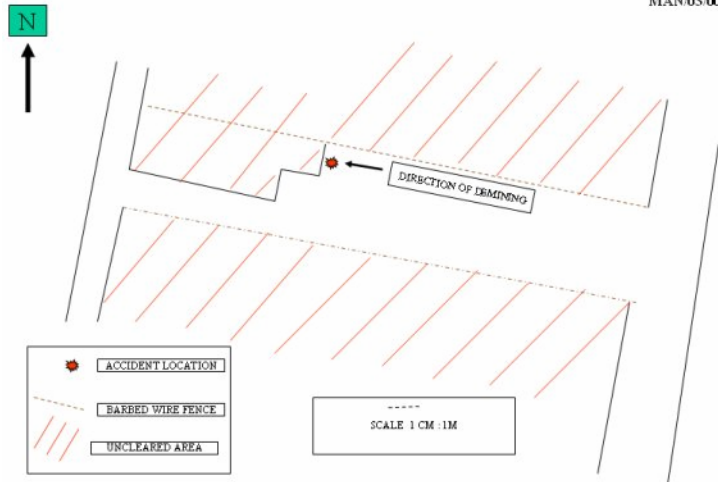
A sketch map of the accident site.

(The area is located between 2 barbwire fences. The soil is heavily contaminated by metal from rusty fence and domestic scrap. The soil is constituted by sand and ash from an old bakery located close to the fence.)
