DDASaccident427

Humanitarian Demining Accident and Incident Database
AID

DDAS Accident Report

Report date: 31/07/2006	Accident number: 427
Accident time: 07:50	Accident Date: 26/06/2003
Where it occurred: Talaimannar Pier, Mannar district	Country: Sri Lanka
Primary cause: Unavoidable (?)	Secondary cause: Inadequate equipment (?)
Class: Missed-mine accident	Date of main report: 12/08/2003
ID original source: MAN/03/001	Name of source: [Name removed]
Organisation: [Name removed]	
Mine/device: Type 72 AP blast	Ground condition: dry/dusty metal fragments sandy
Date record created: 29/07/2006	Date last modified: 31/07/2006
No of victims: 1	No of documents: 4

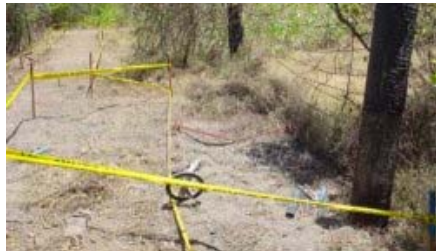
According to the deminer statement He has cleared the line about 1 m to 1,5 meter and made search for signal in one location he got more signals and have made a deep hole to try to located the signals when he was satisfy with the investigation of the hole he has moved his base stick and got up from his knee position to take the gardening shear in order to cut side vegetation at that time his left leg twisted skid towards in the previous excavation hole . Immediately he heard some noise and sand and dust all over his body the smoke also coming from the direction and he fell down. Prior to the explosion, the casualty had been getting multiple signals from the large amount of disintegrating barbed wire in the area. He was confused by the large number of signals and failed to investigate all of them, believing then to be barbed wire fragments.

[A picture of the accident site is shown above.]

l) The area where the deminer was working in a heavily metal contaminated area, (adjacent to rusting barbed wire exposed to salt sea air for the last ten years) the signals from the mine detector may have confused the deminer.

(The area is located between 2 barbwire fences. The soil is heavily contaminated by metal from rusty fence and domestic scrap. The soil is constituted by sand and ash from an old bakery located close to the fence.)

a) Detectors will not be used in the heavily metal contaminated area like between old rusty barbed wire fence. These areas should be cleared using excavation methods down to a minimum depth of 15cms.
