DDASaccident428

DDAS Accident Report

INVESTIGATION REPORT

INTO MINE ACCIDENT WHICH OCCURRED ON 01 AUGUST 2002 AT M4176 MINEFIELD, BANTEAY MEANCHAY.

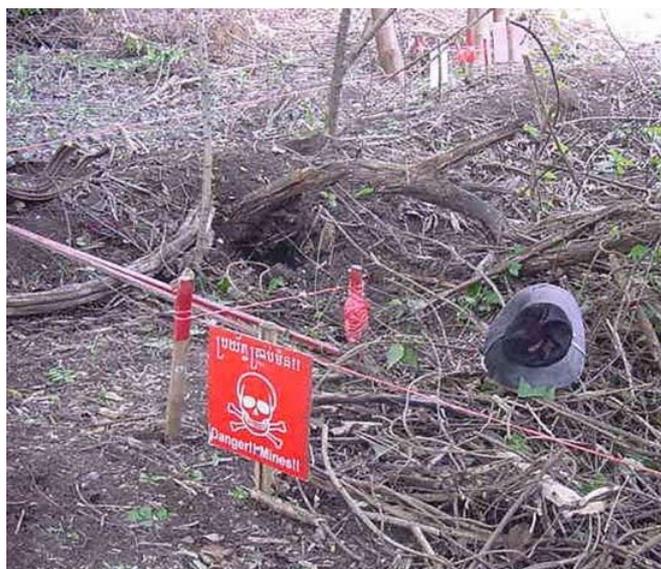
The picture shows the accident site with the Victim's sunhat beside the crater.

A) During conducting Vegetation Removal Drills at minefield M4176, to pull a branch of deadwood which its end buried in a mound of excavated soil from the uncleared area at the head of lane and it was activated and detonated to a buried mine underneath.

A) Yes. A bulldozer was used to clear a field exploding mines as it progressed as well as making a range of mounds at the end of the field which buried deadwood and an unknown quantity of mines. [Demining group] deminers wherever possible, level by level, cleared and continue to clear as many of these mounds as possible. There were mounds of earth at the accident site.

[The ground shown in the photographs is soft and friable with buried, rotting wood – buried by the bulldozer.]

A) All deminers, Section Commanders are to be refresher training on demining drills, basically on vegetation removal drill, Mine detector drill and Prodder and Excavation drill.

6. The investigation team after consideration of all factors makes the following recommendations:
 - a. Strictly reinforce control and monitor by section commander and platoon commander on demining operations performance drills and coaching basic instruction specifically upon its nature.
 - b. All deminers and Section Commanders are to be refreshed training on demining operations drill.
 - c. Mobile Platoon Commanders shall be trained on 1st line and middle management.
 - d. Information from this and other accident/incident investigations should be forwarded to the appropriate CMAC departments for perusal and discussion.

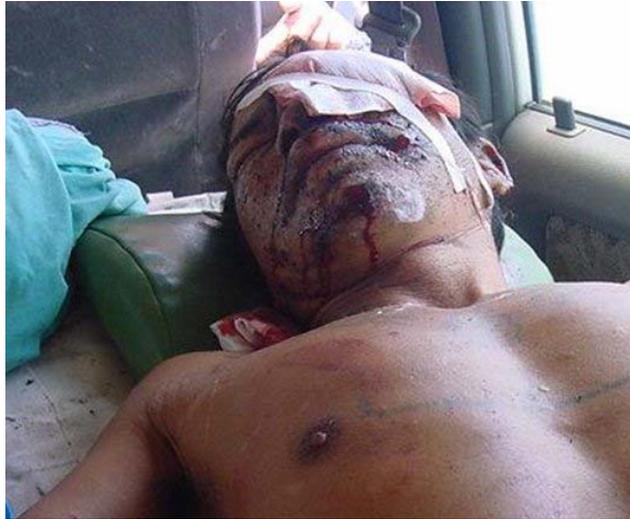
A) Only one person, the victim, was injured. He suffered a blast injury to the face and gravely hurt to left eye, which might be lost sight or blind.

A photograph showed head, left eye and facial injury.
