DDAS Accident Report

Report date: 01/08/2006	Accident number: 430
Accident time: 10:30	Accident Date: 20/02/2001
Where it occurred: 4km N.W. Omhajer Village, Gash Barka	Country: Eritrea
Primary cause: Unavoidable	Secondary cause: Management control inadequacy
Class: Survey accident	Date of main report: 27/02/2001
ID original source: [Name removed]	Name of source: [Name removed]
Organisation: [Name removed]	
Mine/device: AT blast	Ground condition: Unsurfaced road
Date record created: 01/08/2006	Date last modified: 01/08/2006
No of victims: 1	No of documents: 4

REPORT OF BOARD OF INQUIRY INTO LANDMINE INCIDENT 20 FEBRUARY 2001

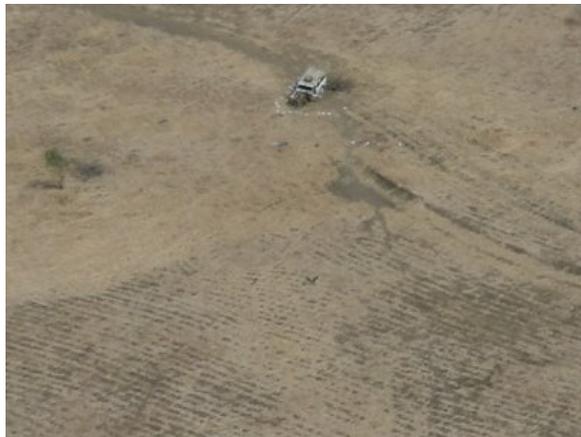
11. The area where the incident occurred is rough terrain, generally flat or gently sloping. Grass and vegetation is very sparse, the area is currently almost barren but is ploughed in preparation for planting and some parts of the area are thinly covered with small trees and bushes. The ground was dry at the time of the incident.

17. Photographs of the area are shown at Annex D. [One is reproduced below.]

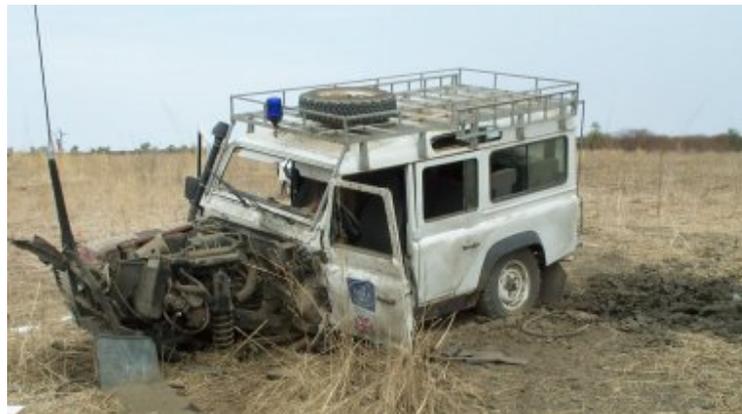
2. At approximately 11:00hrs on 20 February, a left hand drive Land Rover with add-on armour for mine protection, crewed by a [Demining group] Survey Team struck a landmine. The vehicle's front left wheel area and part of the engine were extensively damaged. There were no serious injuries.

47. The effects of the detonation caused the Land Rover to be thrown around, away from the original direction of travel. See photographs at Annex D.

71. The vehicles were travelling southeast along the unsurfaced track, at a speed of approximately twenty-five kilometres per hour. The lead vehicle was approximately twenty-five metres in front of the following vehicle; this estimation was taken from the [Demining group] commander of the second vehicle [name removed]. After driving for approximately five minutes, the leading vehicle drove over an anti tank mine, causing the front end of the Land Rover to become severely damaged.

101. The unsurfaced track should be flailed and UNMEE should provide assistance to recover the damaged vehicle.
