DDASaccident431

DDAS Accident Report

Report date: 02/08/2006	Accident number: 431
Accident time: 08:45	Accident Date: 07/08/2004
Where it occurred: BF 23003 Dararweyne bunkers	Country: Somaliland
Primary cause: Unavoidable (?)	Secondary cause: Other (?)
Class: Excavation accident	Date of main report: 12/08/2004
ID original source: Name removed	Name of source: Name removed
Organisation: Name removed	
Mine/device: Fuze	Ground condition: building rubble
Date record created: 02/08/2006	Date last modified: 02/08/2006
No of victims: 1	No of documents: 1

Accident Investigation Report

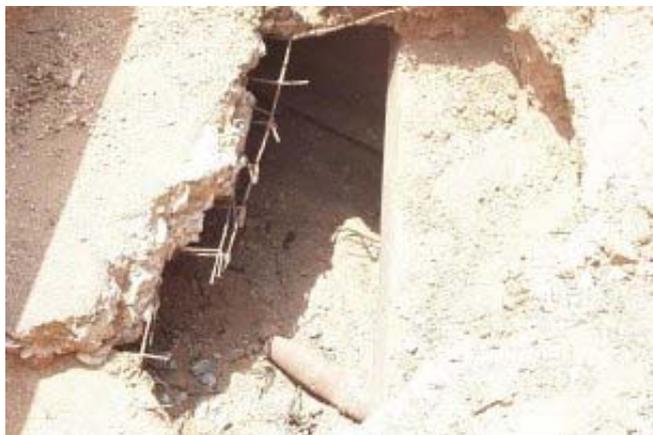
The injured deminer has hit the detonator

The area was been tightened and dim. [Confined space with poor light.]

[The photograph above shows] where the accident happened.]

The incident is classed as a "*Excavation incident*" because the victim had hand and leg injury and a photograph shows an accident site that implies the victim was reaching down into a cavity, perhaps with one leg inside the cavity when the fuze was initiated by his activity. The report states that he "hit the detonator" but does not explain what with, so a hand-tool is presumed.

* Seek advice with the UNDP MA operational Advisor
