DDASaccident432

Humanitarian Demining Accident and Incident Database

DDAS Accident Report

Report date: 11/08/2006	Accident number: 432
Accident time: 13:05	Accident Date: 30/10/2002
Where it occurred: MF ID 1000552, na lokaciji Prebisali?-Kratine-Srbinje	Country: Bosnia Herzegovina
Primary cause: Other (?)	Secondary cause: Other (?)
Class: Other	Date of main report:
ID original source: BiH MAC	Name of source: [Name removed]
Organisation: [Name removed]	
Mine/device: PROM-1 AP Bfrag	Ground condition: grass/grazing area woodland
Date record created: 11/08/2006	Date last modified: 11/08/2006
No of victims: 1	No of documents: 1

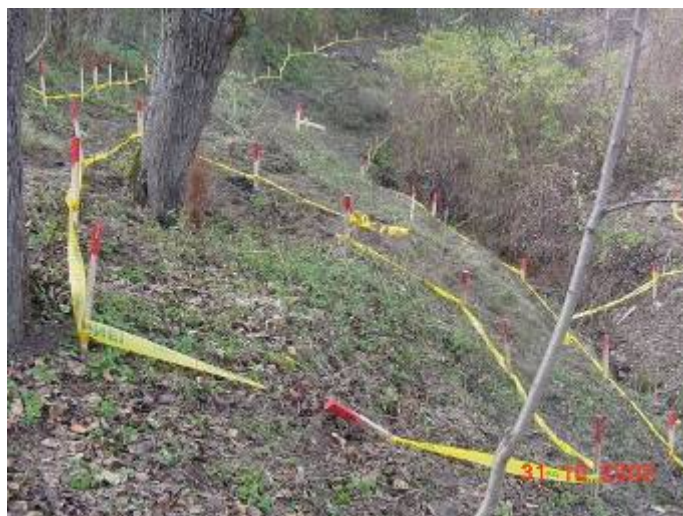
Photographs show the victim appeared to land on top of the marking tape. The area was a grassed incline alongside a wooden picket fence with woodland behind.

Photographs are confusing. A mature tree (45cm diameter approx) may have caused an obstruction in the clearance lane. Certainly a box around the tree was left, and parts of the victim were photographed on the marking for the edge of that box.

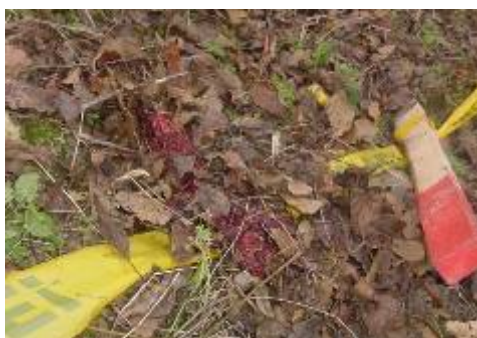
A photograph of the crater was present with the PROM circle easily seen, although the baseplate had not been recovered.

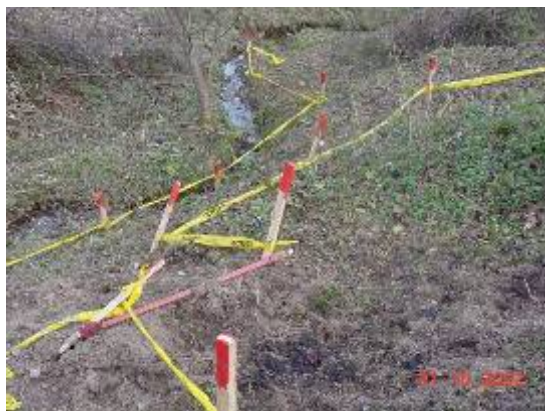
The photograph alongside appears to show the start of a lane and the deminer's red basestick, with the crater in front of the basestick. From this it is inferred that the victim initiated the mine in front of the marking.

The victim suffered severe foot damage from which an amputation is inferred.
