DDAS Accident Report

Report date: 14/07/2011	Accident number: 438
Accident time: 13:20	Accident Date: 19/02/2006
Where it occurred: LK-241 SL, Periyavillan village, Valikamam, Southwest Jaffna	Country: Sri Lanka
Primary cause: Unavoidable (?)	Secondary cause: Field control inadequacy (?)
Class: Handling accident	Date of main report: 20/02/2006
ID original source: None	Name of source: Demining group
Organisation: [Name removed]	
Mine/device: P4 AP blast Fuze	Ground condition: not applicable
Date record created: 16/03/2007	Date last modified: 14/07/2011
No of victims: 1	No of documents: 1

INVESTIGATION REPORT OF DEMINING ACCIDENT IN JAFFNA 19 FEBRUARY 2006

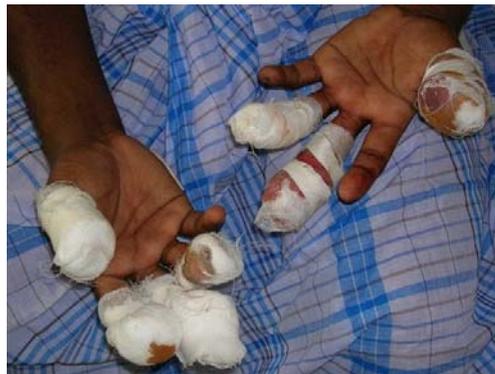
"...injuries to his left hand and right hand fingers [hands required surgery] and to the top of his left eye".

Code	Meaning	Check mark
A	Abrasions	X
AM	Amputation	X
B	Burn	
D	Dislocation	
F	Fracture	
FR	Fragment	X
H	Haemorrhage	X
IF	Internal Haemorrhage	
L	Laceration	
LO	Loss of function	X

And recorded that the tips of fingers had been amputated.
