DDASaccident439

DDAS Accident Report

Report date: 17/03/2007	Accident number: 439
Accident time: 12:20	Accident Date: 14/10/2003
Where it occurred: IMSMA ID: LK 133 Urumpirai Minefield, Kopay Division, Jaffna	Country: Sri Lanka
Primary cause: Field control inadequacy (?)	Secondary cause: Unavoidable (?)
Class: Excavation accident	Date of main report: 16/10/2003
ID original source: none	Name of source: Private
Organisation: [Name removed]	
Mine/device: P2Mk2 P4Mk1 AP blast	Ground condition: grass/grazing area hard
Date record created: 17/03/2007	Date last modified: 17/03/2007
No of victims: 1	No of documents: 3

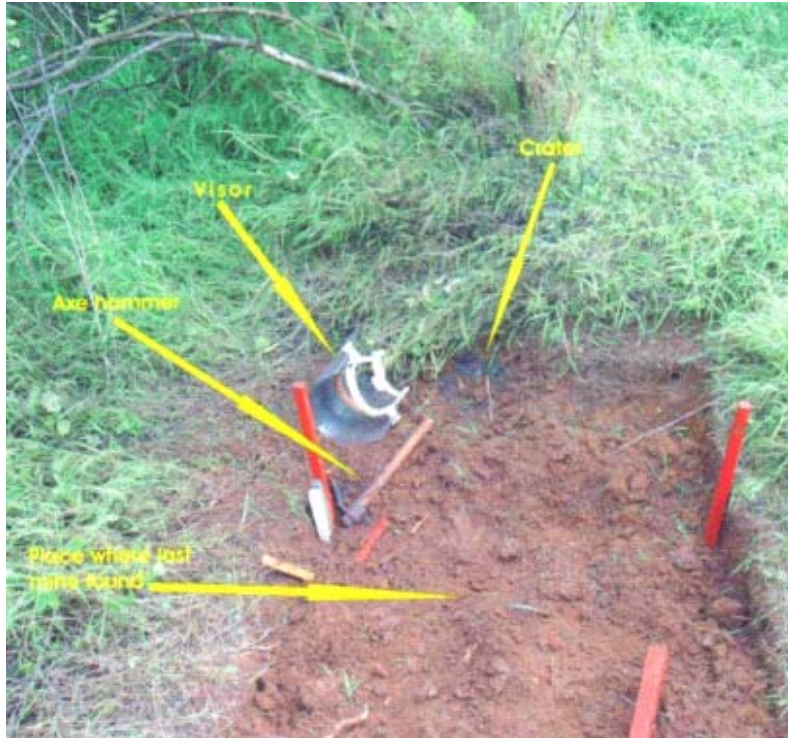
Narrative: The deminer [Name excised] was carrying out one man one lane manual demining drills in accordance with [Demining group] Sri Lanka manual demining SOPs for 100% excavation. He was using the axe hammer tool to excavate the face of his lane down to a depth of 15cm, when the detonation occurred. The mine detonated on the left hand side of his lane as he was using the axe hammer.

[The picture above shows the accident site]

[The type of mine involved was the Type 72 A, as] Determined by: Direct observation
Fragments found. The mine detonated completely leaving a crater of approx 50 cm across and 25 cm deep.

2. At the left hand side of the lane, the deminer excavated a block of soil when the blast occurred. In a debriefing after giving his statement, the deminer claimed that there was a block of hard soil at the left hand side of his lane. After 2 attempts to scrape it from the right to left, he tried to repeat that action from left to right and then the accident happened. This information leads to the possibility that the hard soil block pressed on the mine and caused the accident. But, a close look at the Axe-Hammer blade's edge implies that the deminer hit the mine with his digging tool. The blast marks and dust on the blade are spread from a point in the middle of the blade's edge, backwards toward the rear side of the Axe Hammer which indicated that the deminer was digging from top to bottom. Obviously this is a breach of the HALO Trust Standard Operating Procedures (SOPs).

4. The actual location of the mine was aside from the lane of the other mines that were found at the same lane (see figure 7). There is a high possibility that the deminer was expecting the mine to be more at the centre of his lane and therefore allowed himself to hit the ground hardly at the left side of his lane.
5. Both the Section Commander (S/CO) and the Task Commander (T/C) should have paid a closer attention to the way that the deminer was conducting his drills. The minefield is an open area therefore it is possible for the S/CO and T/C to see the deminers operating at all times.
6. The CASEVAC procedure was fast and good, but the reporting back to the office and to the O/IC was delayed due to poor coverage of the cellular phone net. In the end, the information was delivered by radio to the next minefield and from there by phone to the O/IC.

6. In cases of hard soil, the use of water should take place to soften the ground prior to excavating. This will prevent the use of force while using excavating tools.

7. In lanes that follow mine lines, especially when there is a clear picture of the distance between mines, deminers should avoid working with Axe-Hammer and use the smaller scraper instead.

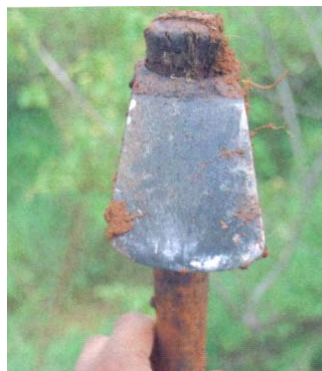
Equipment damaged: Axe Hammer, Metal axe head damaged by blast. No damage was caused to any [other] equipment. Some dust is visible on the outer face of the visor, as well as gloves and hammer scraper. Small blast marks on the hammer scraper. The deminer's body armour was unaffected by the blast.

[A picture of the tool after the accident is shown above.]
