DDASaccident439

DDAS Accident Report

Report date: 17/03/2007	Accident number: 439
Accident time: 12:20	Accident Date: 14/10/2003
Where it occurred: IMSMA ID: LK 133 Urumpirai Minefield, Kopay Division, Jaffna	Country: Sri Lanka
Primary cause: Field control inadequacy (?)	Secondary cause: Unavoidable (?)
Class: Excavation accident	Date of main report: 16/10/2003
ID original source: none	Name of source: Private
Organisation: [Name removed]	
Mine/device: P2Mk2 P4Mk1 AP blast	Ground condition: grass/grazing area hard
Date record created: 17/03/2007	Date last modified: 17/03/2007
No of victims: 1	No of documents: 3

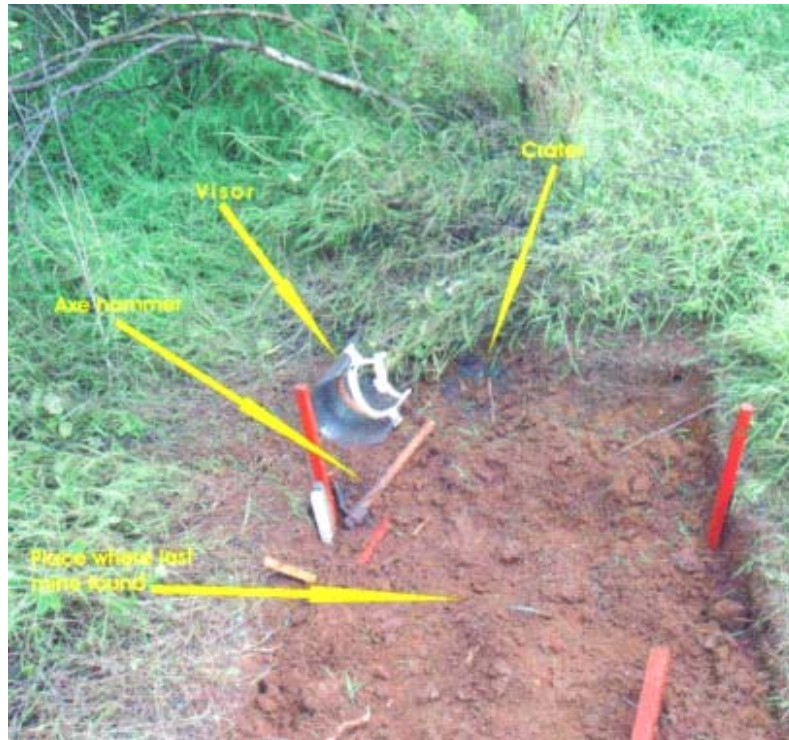
Narrative: The deminer [Name excised] was carrying out one man one lane manual demining drills in accordance with [Demining group] Sri Lanka manual demining SOPs for 100% excavation. He was using the axe hammer tool to excavate the face of his lane down to a depth of 15cm, when the detonation occurred. The mine detonated on the left hand side of his lane as he was using the axe hammer.

[The picture above shows the accident site]

[The type of mine involved was the Type 72 A, as] Determined by: Direct observation
Fragments found. The mine detonated completely leaving a crater of approx 50 cm across and 25 cm deep.

1. The deminer initiated the mine with his Axe Hammer while conducting a full excavation. At this minefield, due to a high metal contamination, the deminers are not using Metal Detector, but excavating all the land to the depth of 15 cm. The blast took place 1 meter away from the last mine that he found. The deminer should have known better to work more carefully, especially after that he found 3 mines at the same lane with intervals of 1 meter from each other.

2. At the left hand side of the lane, the deminer excavated a block of soil when the blast occurred. In a debriefing after giving his statement, the deminer claimed that there was a block of hard soil at the left hand side of his lane. After 2 attempts to scrape it from the right to left, he tried to repeat that action from left to right and then the accident happened. This information leads to the possibility that the hard soil block pressed on the mine and caused the accident. But, a close look at the Axe-Hammer blade's edge implies that the deminer hit the mine with his digging tool. The blast marks and dust on the blade are spread from a point in the middle of the blade's edge, backwards toward the rear side of the Axe Hammer which indicated that the deminer was digging from top to bottom. Obviously this is a breach of the HALO Trust Standard Operating Procedures (SOPs).

4. The actual location of the mine was aside from the lane of the other mines that were found at the same lane (see figure 7). There is a high possibility that the deminer was expecting the mine to be more at the centre of his lane and therefore allowed himself to hit the ground hardly at the left side of his lane.
5. Both the Section Commander (S/CO) and the Task Commander (T/C) should have paid a closer attention to the way that the deminer was conducting his drills. The minefield is an open area therefore it is possible for the S/CO and T/C to see the deminers operating at all times.
6. The CASEVAC procedure was fast and good, but the reporting back to the office and to the O/IC was delayed due to poor coverage of the cellular phone net. In the end, the information was delivered by radio to the next minefield and from there by phone to the O/IC.

1. All operation in [Demining Group] Trust minefields will stop for the next 2 days and every deminer will go through refresher training in conducting a full excavation method of mine clearance.

2. An "actions on" paragraph be inserted into [Demining Group] Sri Lanka manual demining SOPs detailing the requirement to work evenly and systematically when excavating on hard soil

6. In cases of hard soil, the use of water should take place to soften the ground prior to excavating. This will prevent the use of force while using excavating tools.

7. In lanes that follow mine lines, especially when there is a clear picture of the distance between mines, deminers should avoid working with Axe-Hammer and use the smaller scraper instead.
