# DDASaccident441

# DDAS Accident Report

<b>Report date:</b> 17/03/2007	<b>Accident number:</b> 441
<b>Accident time:</b> 11:00	<b>Accident Date:</b> 08/10/2003
<b>Where it occurred:</b> Talailmannar Pier East, Mannar District	<b>Country:</b> Sri Lanka
<b>Primary cause:</b> Unavoidable (?)	<b>Secondary cause:</b> Field control inadequacy (?)
<b>Class:</b> Missed-mine accident	<b>Date of main report:</b> 11/10/2003
<b>ID original source:</b> SF, MF, CH: MAN/03/002	<b>Name of source:</b> Private
<b>Organisation:</b> [Name removed]	
<b>Mine/device:</b> Type 72 AP blast	<b>Ground condition:</b> building rubble electromagnetic hard metal fragments metal scrap residential/urban rocks/stones soft
<b>Date record created:</b> 17/03/2007	<b>Date last modified:</b> 17/03/2007
<b>No of victims:</b> 1	<b>No of documents:</b> 1

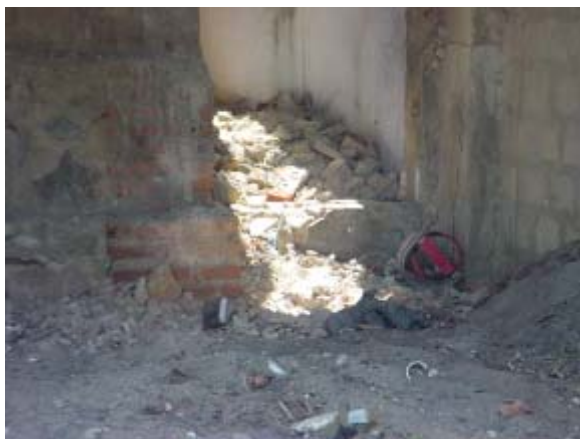
[A picture of the accident site – inside a rubble-strewn building – is shown below. The mine crater is alongside the fallen visor.]

The crater was around 12 cm deep and 30 cm wide some parts of plastic body of the mine were found inside and around the crater. Due to the nature of the ground inside the building – sand mixed with rubble – it was quite difficult to determine the exact depth and diameter of the crater.

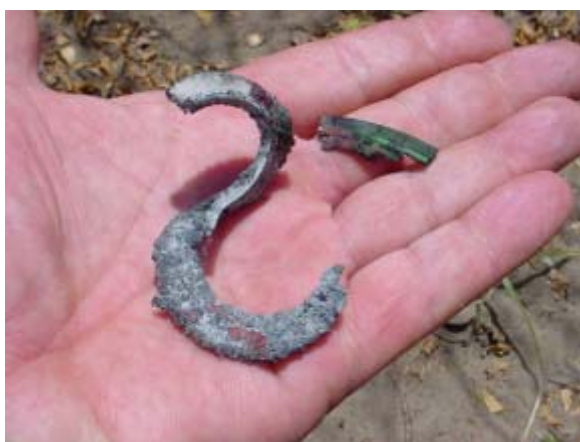
[Parts of the mine are shown below.]

The deminer was walking backwards and reaching the rear wall (his left foot must have had a distance of approx. 30cm from the wall/doorway) to fill his shovel again, as he must have stepped on the AP mine (Chinese Type 72 A) and an uncontrolled detonation occurred. The detonation caused the traumatic amputation of his left foot.

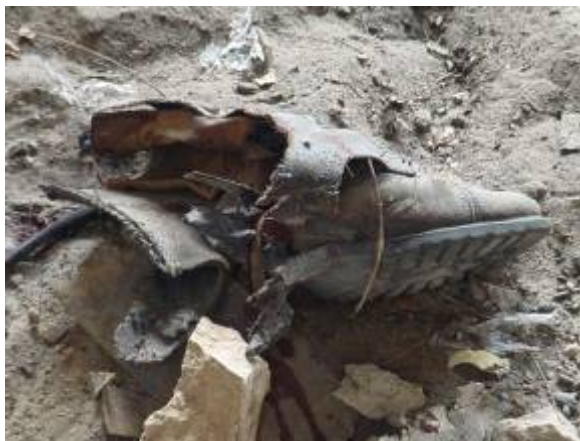
The Victim was wearing PPE and visor, and there was "no damage on PPE/Visor resulting to the blast or projection of plastic parts of the mine body".

[The Victim's left shoe is shown below.]
