DDASaccident441

Humanitarian Demining Accident and Incident Database

DDAS Accident Report

Report date: 17/03/2007	Accident number: 441
Accident time: 11:00	Accident Date: 08/10/2003
Where it occurred: Talailmannar Pier East, Mannar District	Country: Sri Lanka
Primary cause: Unavoidable (?)	Secondary cause: Field control inadequacy (?)
Class: Missed-mine accident	Date of main report: 11/10/2003
ID original source: SF, MF, CH: MAN/03/002	Name of source: Private
Organisation: [Name removed]	
Mine/device: Type 72 AP blast	Ground condition: building rubble electromagnetic hard metal fragments metal scrap residential/urban rocks/stones soft
Date record created: 17/03/2007	Date last modified: 17/03/2007
No of victims: 1	No of documents: 1

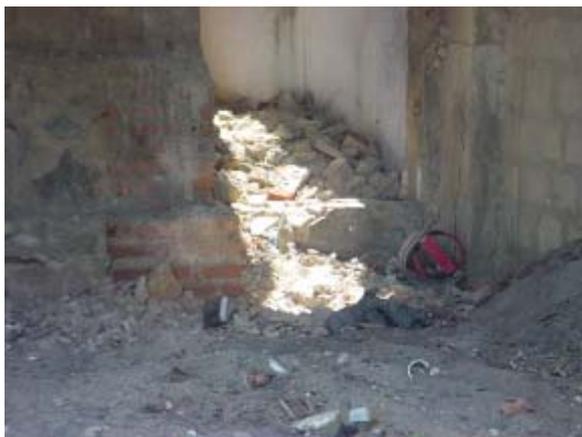
[A picture of the accident site – inside a rubble-strewn building – is shown below. The mine crater is alongside the fallen visor.]

Narrative: During the removal of rubble, sand and rubbish in a holding area inside a building (area has been cleared with metal detector and excavation drills in April 2003 by [the same demining group]), the deminer was walking backwards and reaching the rear wall to fill his shovel again, as an uncontrolled detonation occurred. The detonation caused the traumatic amputation of his left foot.

The crater was around 12 cm deep and 30 cm wide some parts of plastic body of the mine were found inside and around the crater. Due to the nature of the ground inside the building – sand mixed with rubble – it was quite difficult to determine the exact depth and diameter of the crater.

(3) The entire inside of the building (shop) must be re-excavated. All sensitive areas (backside of the buildings, doorways and outside windows) in the southern part of the minefield, which will be handed over soon, have to be re-checked. In addition all holding areas have to be re-checked.

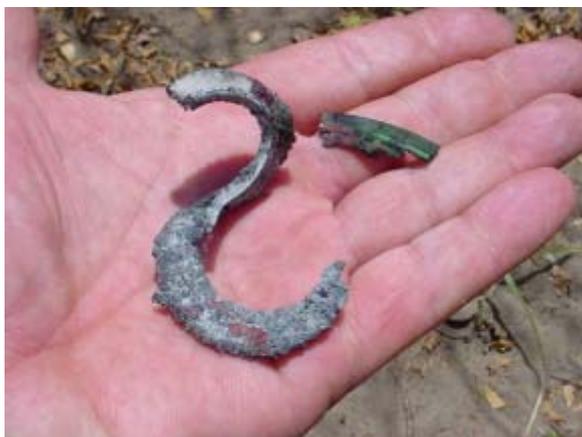
[Parts of the mine are shown below.]

The deminer was walking backwards and reaching the rear wall (his left foot must have had a distance of approx. 30cm from the wall/doorway) to fill his shovel again, as he must have stepped on the AP mine (Chinese Type 72 A) and an uncontrolled detonation occurred. The detonation caused the traumatic amputation of his left foot.

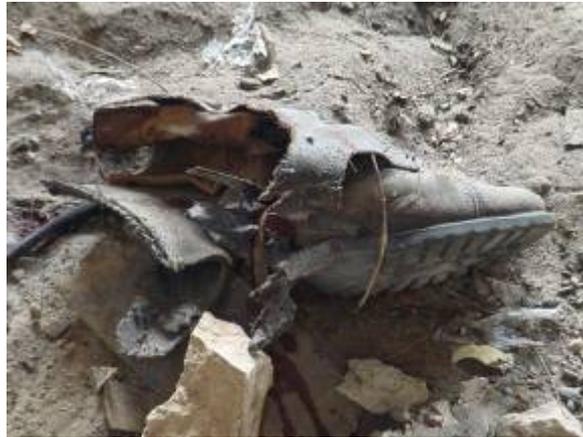
The Victim was wearing PPE and visor, and there was "no damage on PPE/Visor resulting to the blast or projection of plastic parts of the mine body".

[The Victim's left shoe is shown below.]
