DDASaccident442

Humanitarian Demining Accident and Incident Database
AID

DDAS Accident Report

Accident Investigation & Board of Inquiry: 8th July 2004

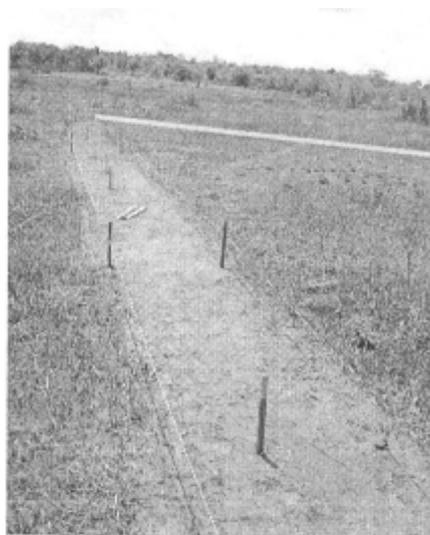
General view facing East along the safe lane where accident took place. Note yellow pickets denoting the location of previous days P-4 AP blast mine finds.

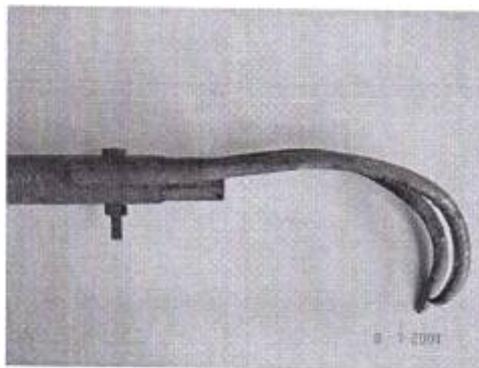
Heavy rake showing minor damage to one of the two prongs.

The only damage to equipment was very slight blast damage to the point of one prong of the heavy rake and damage to the inside of the visor. The damage and blast marks to the visor could only have accrued if the visor was up at the time of the explosion.

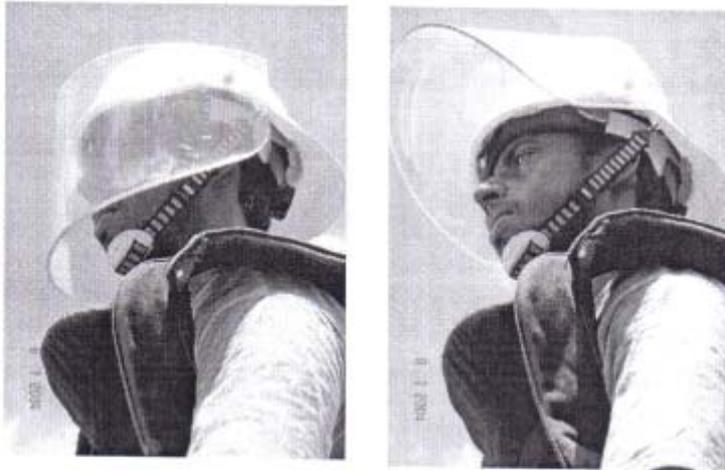
The BOI could not establish conclusively why the accident took place, as no eye witnesses saw the incident at the time of the explosion. However, it was obvious that the deminer had his visor up at the time of the explosion. Damage and blast marks to the inside of the visor could not have accrued if the visor was down at the time of the explosion. The deminer insisted that the visor was down at the time of the explosion but could give no explanation to how the accident took place. It is the opinion of the BOI that the injuries to the deminer's face were a direct result of the deminer's failure to follow the organisation's SOPs. The deminers lack of attentiveness may also have been a major contributing factor to the accident.

The physical evidence proves that the deminer visor was up at the time of the explosion. However, the deminer denied that he was working with the visor up, but could give no plausible reason for the accident. A definitive cause of the accident could not be found as the deminer was the only eye witness at the time of the explosion, but his statement contradicts the physical evidence. This contradiction combined with the Section Leader's statement that the deminer was reprimanded for working with his visor up, just minutes before the accident, leads the BOI to deduce that the deminer was not attentive at the time of the accident. Although [Demining Group] has been using the rake method since they started demining operations this is the first reported accident during raking demining operations. Therefore an error in drills due to a lack of concentration, seem the logical cause of the accident.

Mines eye view showing deminer with visor up and down. The blast pattern on the deminer's helmet indicated that the deminer had the visor up and was looking to the right, as demonstrated in the photo above.

[Demining Group] should conduct short refresher training to highlight the issues raised in this report and to reinforce the importance of following the agencies SOPs.

The agencies involved should consider taking appropriate disciplinary action against the deminer, as they deem fit.
