# DDASaccident444

# DDAS Accident Report

<b>Report date:</b> 28/12/2007	<b>Accident number:</b> 444
<b>Accident time:</b> 09:00	<b>Accident Date:</b> 18/11/2006
<b>Where it occurred:</b> Task 104, Tower 62, Kabul Naghlu Power line, Butkhak village, Bagrami district, Kabul province	<b>Country:</b> Afghanistan
<b>Primary cause:</b> Inadequate survey (?)	<b>Secondary cause:</b> Field control inadequacy (?)
<b>Class:</b> Excavation accident	<b>Date of main report:</b> 28/11/2006
<b>ID original source:</b> OPS/27/447-06	<b>Name of source:</b> UNMACA
<b>Organisation:</b> [Name removed]	
<b>Mine/device:</b> PMN-2 AP blast	<b>Ground condition:</b> rocks/stones soft
<b>Date record created:</b> 28/12/2007	<b>Date last modified:</b> 28/12/2007
<b>No of victims:</b> 1	<b>No of documents:</b> 3

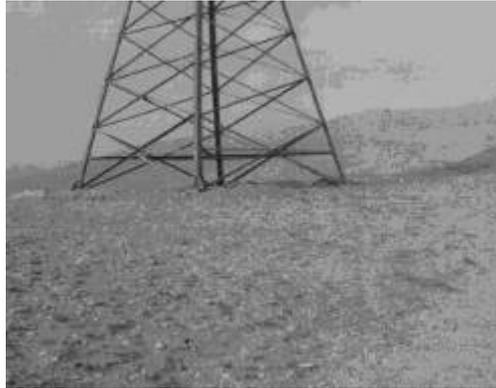
The accident occurred at the base of an electrical tower which forms part of the Kabul to Naghlu Power-line. The towers are numbered from the Kabul end of the line and the accident took place at Tower No 62.

[The accident tower.]

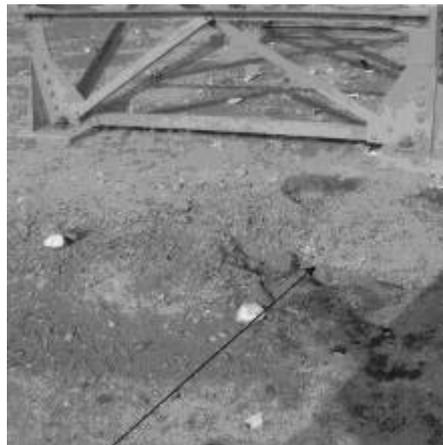
[The accident crater, showing little excavation.]

7. Excavation 62 was not being conducted in accordance with the [Demining group] excavation drill. The Acting TL and the SL both stated that they had instructed the deminers to have 20cm distance x 20cm depth of full excavation to their front at all times. The SOP states that there must be a minimum of 1m fully excavated and all spoil is to be at the rear of the deminer. It was evident at the scene of the accident that virtually no spoil was being removed at all.

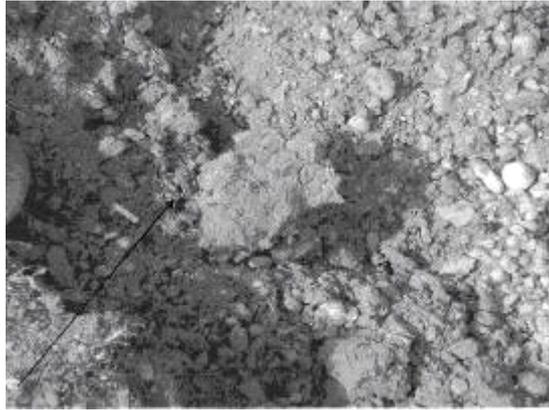
[The accident crater showing friable ground with pebbles.]
