DDASaccident445

DDAS Accident Report

Report date: 28/12/2007	Accident number: 445
Accident time: 07:04	Accident Date: 13/05/2007
Where it occurred: Bahadul-Gaig village, Jabal Seraj district of Parwan province	Country: Afghanistan
Primary cause: Inadequate training (?)	Secondary cause: Management/control inadequacy (?)
Class: Excavation accident	Date of main report: 16/05/2007
ID original source: OPS/03/01-38	Name of source: UNMACA
Organisation: [Name removed]	
Mine/device: PMN AP blast	Ground condition: agricultural (recent) building rubble hard residential/urban
Date record created: 28/12/2007	Date last modified: 28/12/2007
No of victims: 2	No of documents: 3

INTERNAL DETAILED DEMINING ACCIDENT REPORT

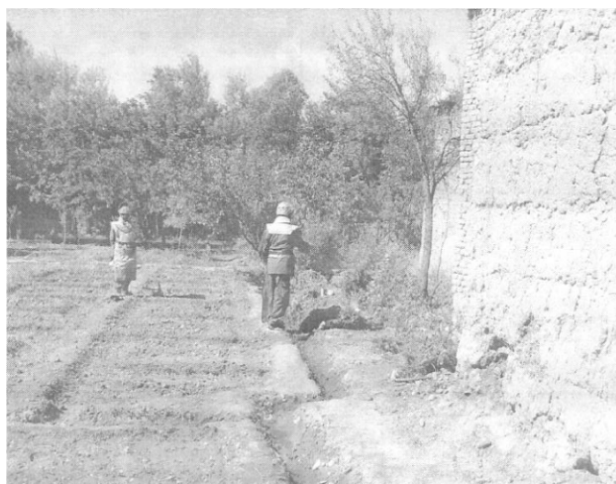
This picture shows the east side of the area outside house wall. The deminer is pointing to the detonation site of the first PMN.

Ground at the site is flat. The soil is baked hard, and compacted by wind and water. It is difficult to probe and excavate.

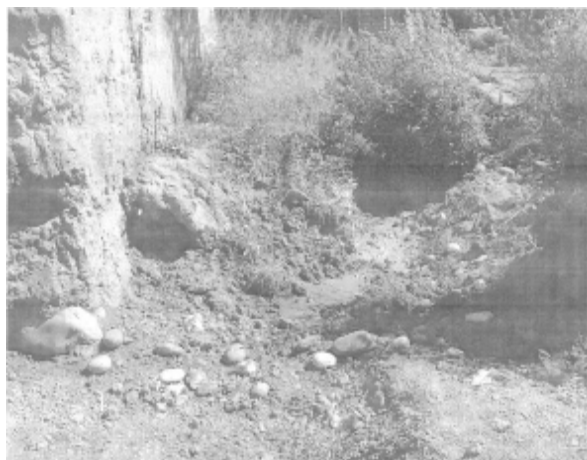
10. Accident cause: Detonation was caused by unintentional contact of the bayonet — type probe (prodder) by the deminer onto the top of the PMN. It is not known why acting SL [Victim no.1] was instructing deminer [Victim no.2] in a "live" minefield.

The location of the PMN detonation is approximately 70-80 cm from the green marking stone [centre of photograph]. This photo was taken the day after the accident. The blast hole is not clearly visible due to mud. Specific depth and size of the hole are not known.

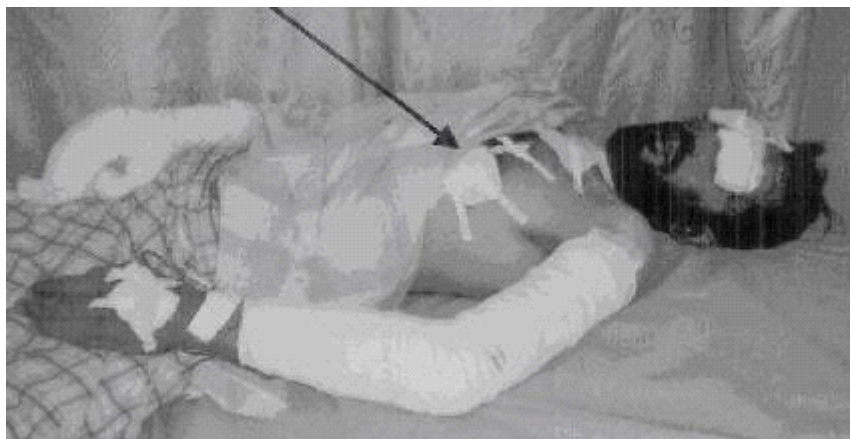
Deminer [Victim no.2]'s eye injury indicates that the Protective Visor was not used at the moment of blast of PMN. Acting SL [Victim no.1]'s chest injury indicates that the Protective Vest was not used at the moment of blast of PMN. It is not known why they were not wearing their PPE as per SOP.

[Victim no.1] who was working as acting section leader received multiple injuries on his face, arms, hands and also a small hole created on his chest. "...has got his right eye completely damaged, left hand got injury and deep hurt in to near his And also left eye got injury".

[Victim no.1: dressed injuries to left hand, right arm, eyes and chest.]

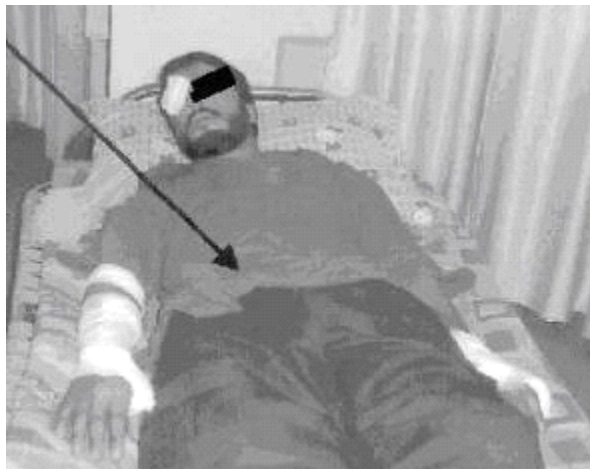
[Victim No.2: dressed injuries to both forearms and right eye.]

During this accident deminer [Victim no.2] was stand near the acting section leader received injuries on his hands, right eye and multiple superficial injures on his face.
