# DDASaccident446

# DDAS Accident Report

Mr [Name removed], Programme Manager for the United Nations Mine Action Centre for Afghanistan (UNMACA) convened a Board of Inquiry (BOI) team tasked with investigating the circumstances into the death of [the Victim], a deminer with the [Demining group], Mine Clearance Team Six ([Demining group] MCT-6).

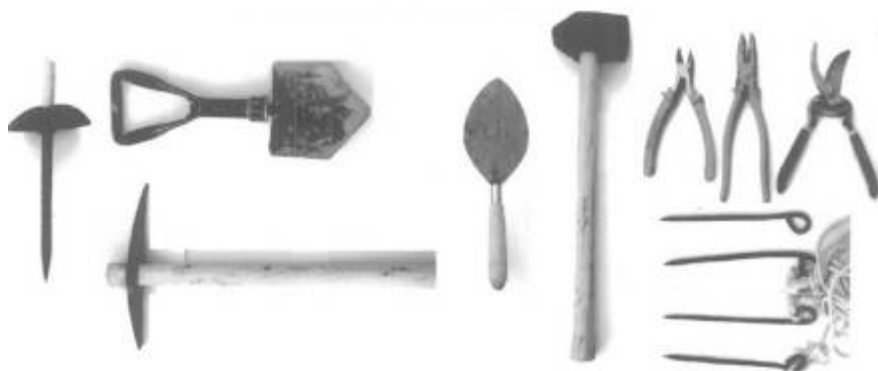
The standard set of issued deminer's equipment/tools were inspected by the BOI investigation team and found to be in good working condition with no visible blast marks that could be attributed to causing the accident. The metal detector was also not damaged.

The exception to this was the 1.0 & 1.2 metre base sticks. Both items were well used with their painted safety markings worn away. While the base stick is painted in accordance with [Demining group] SOPs (Ref - Pt 2, Sect 3, para 3.2) it is not in accordance with the Afghanistan Mine Action Standards (AMAS).

- b. [Demining group] supervisors at all levels are to ensure that correct marking procedures are followed at all times during clearance operations.
- c. [Demining group] SOPs be amended immediately in regard to the correct painting of the base stick from White to Red and that all sticks are re-painted.

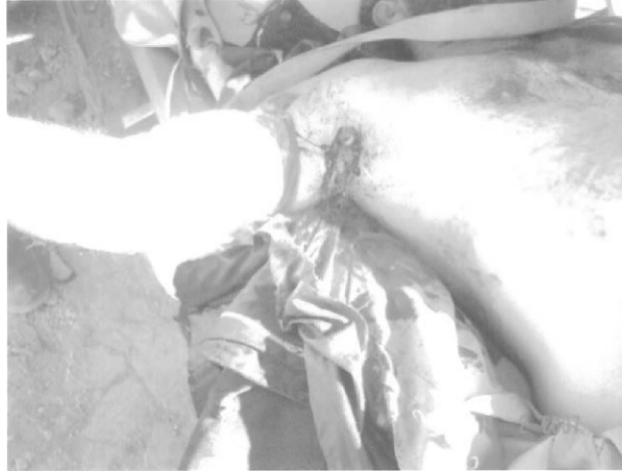
Doctor [Name removed] performed the medical inspection of the victim at the Herat General Hospital. The doctor's report indicates that the victim sustained a severe blast wound below the right armpit and attributed the death to a cardiac arrest.

On further questioning regarding the wound in the right armpit the Dr [Name removed] stated that it was an irregular shaped wound consistent with a blast, and if it were a knife wound it would be a regular shaped wound. Questioned further on whether it could it be a metal shrapnel wound he replied "No that would be a regular shaped wound".

View of Wound to the Armpit

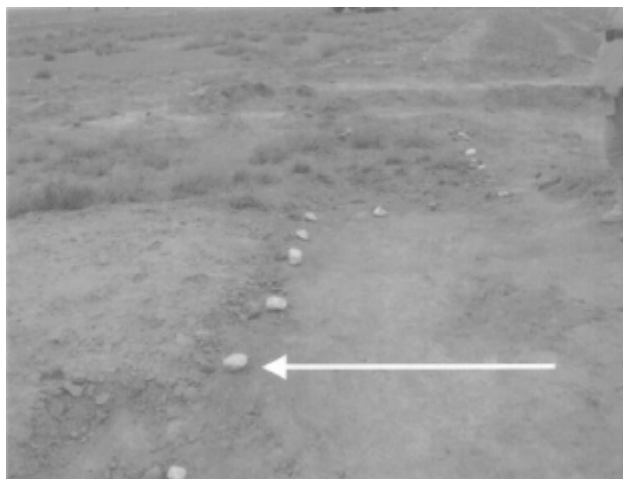
Site Inspection - 15 Feb 07

Note: There are no marking stones on the minefield side of the cleared lane.

Yet there are marking stones on the cleared side of the clearance lane.

The rows of Red & White stones on the right of the clearance lane are incorrect. The area to the right of the clearance lane is a cleared area, therefore, the stones should only be white to designate the lane width and also that the area is cleared.

Note: The marking stones have now been moved to the minefield side of the cleared lane after the accident. This process should occur after each meter of ground is cleared.

- d. [Demining group] SOPs be amended to reflect that all accident sites should be preserved intact until an investigation team's arrival and that all tools and equipment, less valuable items (i.e. Metal Detector), be left as they are found at the time of the accident, when such valuable items are to be removed, accurate details with photographs are to be recorded for the Investigation team.
