DDASaccident447

DDAS Accident Report

Report date: 28/12/2007	Accident number: 447
Accident time: 08:35	Accident Date: 15/05/2007
Where it occurred: Bahadur Baig village, Jabal Seraj district of Parwan province	Country: Afghanistan
Primary cause: Unavoidable (?)	Secondary cause: Management/control inadequacy (?)
Class: Excavation accident	Date of main report: 16/05/2007
ID original source: OPS/03/01-39	Name of source: UNMACA
Organisation: [Name removed]	
Mine/device: PMN AP blast	Ground condition: agricultural (recent) building rubble hard residential/urban
Date record created: 28/12/2007	Date last modified: 28/12/2007
No of victims: 1	No of documents: 3

INTERNAL DETAILED DEMINING ACCIDENT REPORT

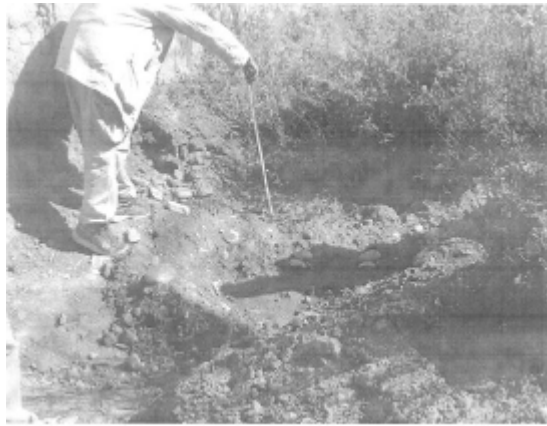
Accident cause: Detonation was caused by unintentional contact of the bayonet — type probe (prodder) by the deminer onto the top of the PMN.

Worksite layout and marking. Worksite was marked in accordance with SOP. This demining task is outside a residential wall; the line is approximately 1.5m wide. 420 out of 470 m² were already completed when the accident occurred.

Location of PMN detonation.

- [Demining group] Operations and QA need to conduct refresher training for all [Demining group] deminers on probing and excavation drills.
- All [Demining group] minefield supervisors, including section leaders, assistant team leaders, and team leaders need to attend a supervisor training program to reinforce SOPs, leadership responsibilities and authority.
- DT 4 must demonstrate safe clearance procedures to a UNMACA or AMAC QA Officer to be re-accredited.

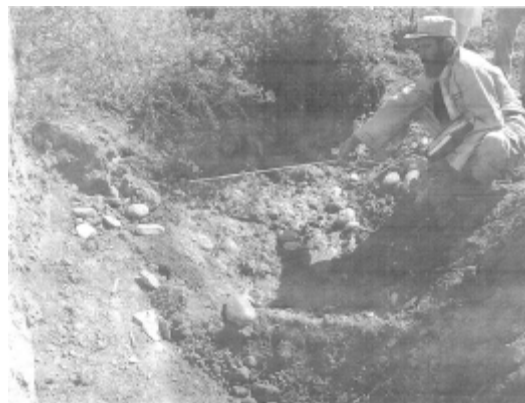
SL indicating the detonation location on east side of the wall on May 15.

d) The investigation report indicates that the accident happened just half a metre from the first accident where some extra soil has gradually come down from a ruin mud wall on the top of the mine, the surface was very hard; it concludes that the team leader has not learnt any lessons from the first accident and has not taken any measures to prevent reoccurrence of the second accident. Also the Team Leader failed to focus more on supervision and control of the team.
