DDAS Accident Report

Report date: 28/12/2007	Accident number: 450
Accident time: 10:00	Accident Date: 05/11/2006
Where it occurred: Task # 130, Good Neighbourhood project, Hassankhail village, Bagram district, Parwan province	Country: Afghanistan
Primary cause: Field control inadequacy (?)	Secondary cause: Management/control inadequacy (?)
Class: Excavation accident	Date of main report: 19/12/2006
ID original source: OPS127/464-06	Name of source: UNMACA
Organisation: [Name removed]	
Mine/device: PMN-2 AP blast	Ground condition: dry/dusty soft
Date record created: 28/12/2007	Date last modified: 28/12/2007
No of victims: 1	No of documents: 3

Demining Investigation Report

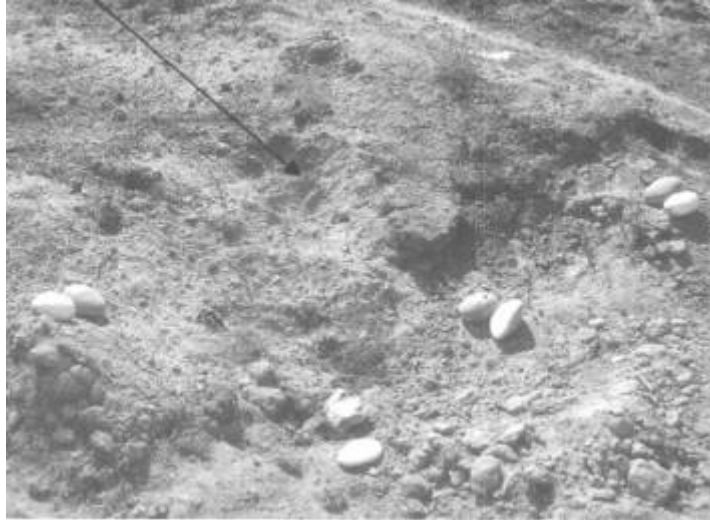
Picture of the accident site, showing shallow excavation.

2. Observing the accident point made obvious that depth of the signal was near the ground surface and excavation depth of the signal (exploded mine) was reduced from 13 cm to 4 cm.

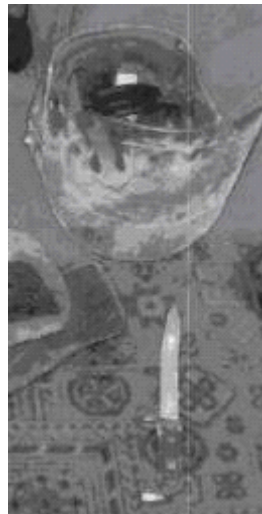
Description of equipment damage: the victim's bayonet was bent.

The picture shows an AK bayonet and dirty visor.

3. When we asked about bayonet of the deminer, they showed us a Russian made bent bayonet, which its use has been prohibited. They pretended that the explosion has bent the bayonet. If the deminer had worked with that bayonet either his right hand was cut or seriously injured, but from injuries of the deminer hand we can say that the deminer has excavated the signal (exploded mine) by portable shovel not by the bayonet.

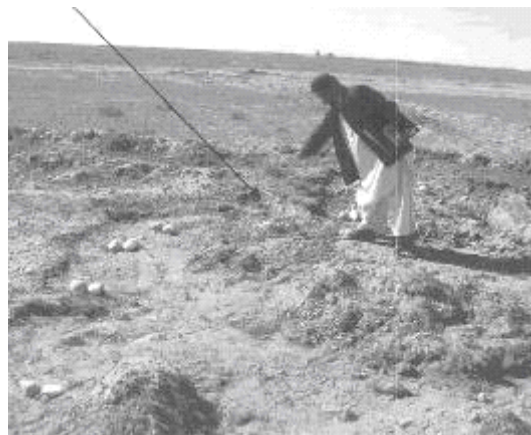
[The photograph shows an investigator at the site – not wearing PPE.]
