### DDASaccident452

# DDAS Accident Report

SUBJECT: ATC DEMINING ACCIDENT ID NO E-04

## Initial Demining Investigation Report

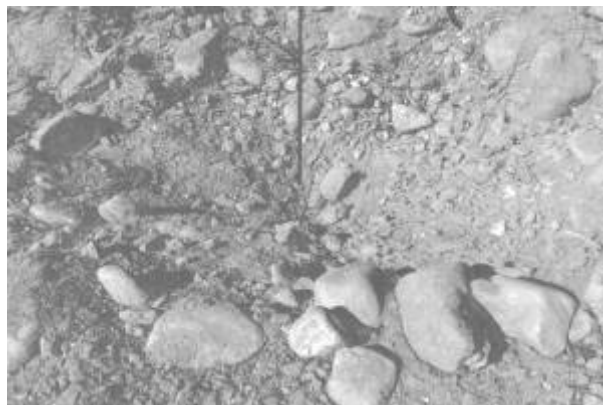
The ground was hard because of draught and sand.

[A photograph of the crater showed that the ground was rocky.]

The area has been observed by investigation team, and the area was uneven and hillside. The position of mine might be changed by floodwater.

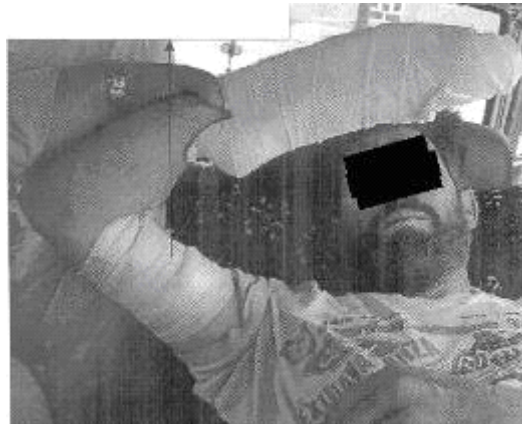
IMSMA record: Rt: pobox and index finger injuries. Right hand injury. Anti brachium multiple injuries. Digitus medius. Right arm injury and left hand injury.

1. Right arm (upper) injury.
2. Assessment of trauma and ABC
3. Bleeding control tie tourniquet heavy bleeding
4. Pass IV canulla to keep veins open
5. Analgesic given uj sosegan 30 ml IV
6. Use of splent

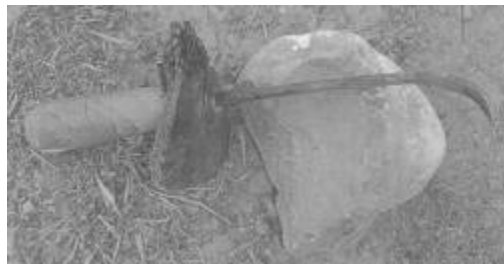
The primary cause of this accident is listed as “Unavoidable” because it seems that the Victim may have been working as directed when the accident happened. The locally made bayonet stayed in one piece and may have reduced the Victim’s injury, but the deminers recognised that the use of the bayonet as an excavation tool may not have been the best choice. The use of the metal detector clearance in an area with a lot of metal fragmentation (and no strong magnets) may also have been unwise. The deminers wanted to prepare the ground mechanically but the machine was busy elsewhere. Because appropriate equipment and systems to conduct the task in safety were not in place, the secondary cause is listed as “Inadequate equipment”.

A photograph showed that the Victim’s bayonet bent as designed and the hand-guard (the side-wall of a tyre) seems to have done its job. The Victim’s hand injuries may have occurred when it was violently twisted from his hand.

I recommend: One Hitachi MDU to be sent to the area for preparation of the area for manual team. New equipments should be provided such as HF and VHF Radios and Visors.
