# DDASaccident454

# DDAS Accident Report

Sub: [Demining Group] Demining accident report

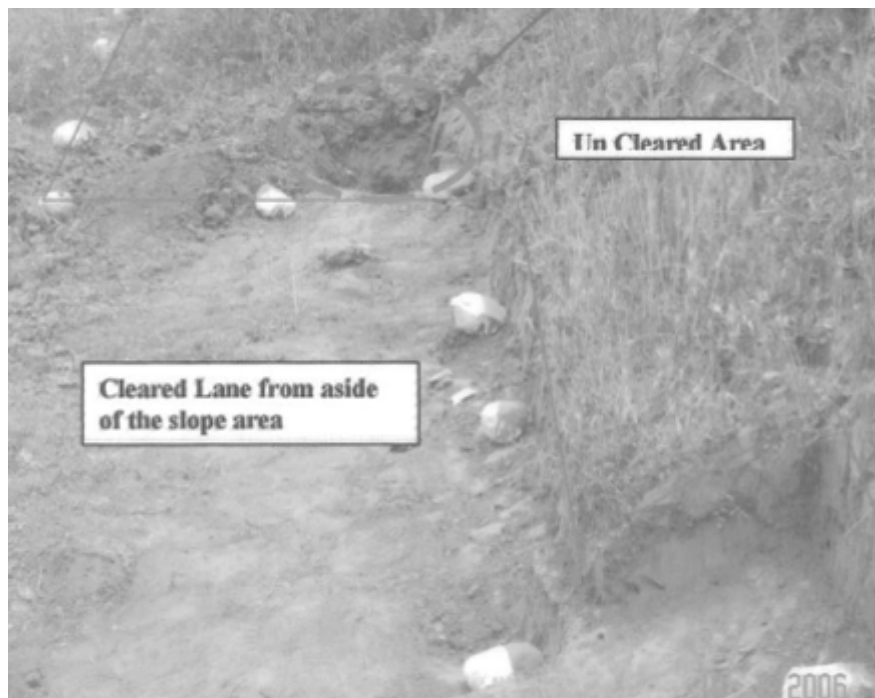
As it is explained that the deminer had worked from aside the slope area where the space was very tight and he couldn't use his hand freely the height and the hardness of the ground and the tightness of the space made him to use the trowel vertically

“Cleared Lane from aside of the slope area”

If the team leader of the team arranged the working lane from down to up side of the slope area the mine may disclose easily and cause no casualty. [A poor photograph actually showed the lane working across the slope side-to-side (slightly downward)]. The actual route of the working lane, which was arranged by the team leader for the deminer to work that caused the accident by doing such.

5. The team leader is recommended to manage the working lane from down to up side of the slope area not from sideways of the hill or slope area up to down position.

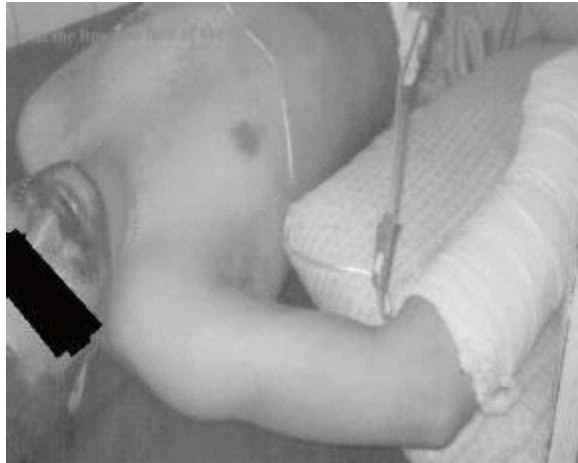
[The photograph shows the right arm bandaged to the elbow and blackened fragmentation injury on the victim's chin extending to his nose.]

One deep wide and serious injury on his right hand with tissue defect and multiple fractures

Upper lip erosion and oedema which is not serious.

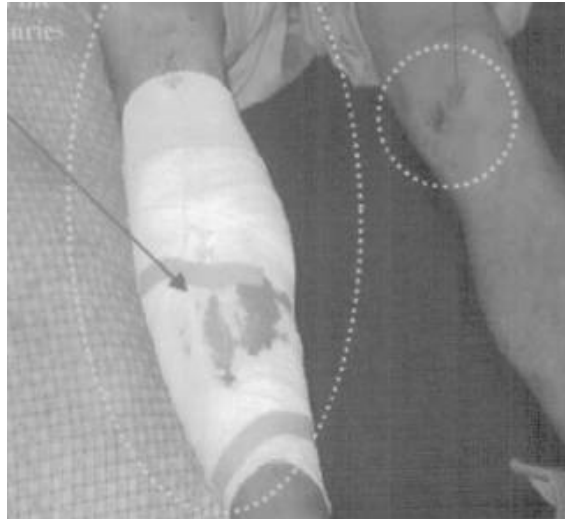
One wide but superficial erosion on his right leg.

And there was some small subcutaneous haematoma and foreign bodies on his both legs and feet.

[The injured legs of the Victim, right leg apparently extensive.]

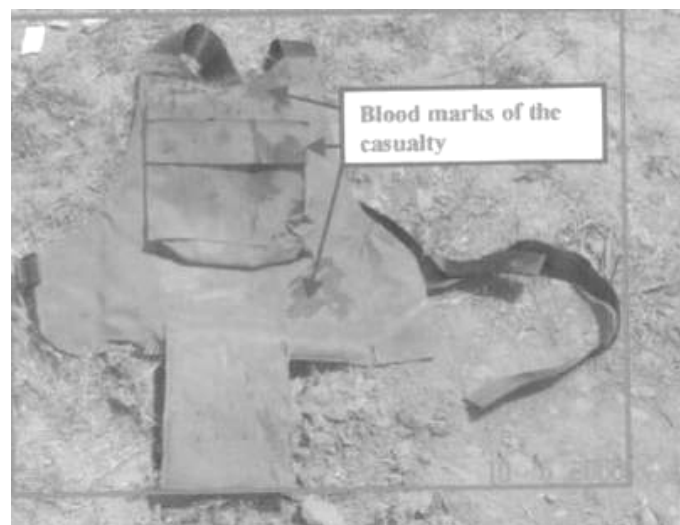
The demining group's continued use of inadequate protection and tools that do not meet the IMAS are the "Management Control Inadequacy" listed as the secondary cause of the accident.

[The photograph shows the minimal frontal protection with no collar to interface with the lower part of the visor, so leaving the throat exposed even when the visor is worn correctly.]
