DDASaccident455

DDAS Accident Report

Mechanical Demining Accident at Chilston - 2 May 2006

M19 AT mine detonated under Gill bucket of a [Demining group]-99 wheeled loader, the loader was engaged in clearing anti-tank minefield.

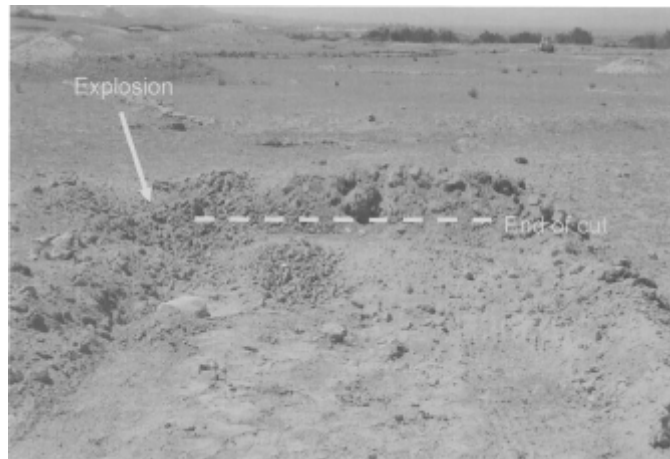
3.1. At approx 10:30, [Name removed], an operator with five years experience on the Case 721, was taking a cut when an AT mine exploded at the left front edge of his Gill bucket (see below).

3.3. There were no casualties. The damage to the bucket was minimal — specifically the left-hand tooth was snapped off, and landed 180 metres away;

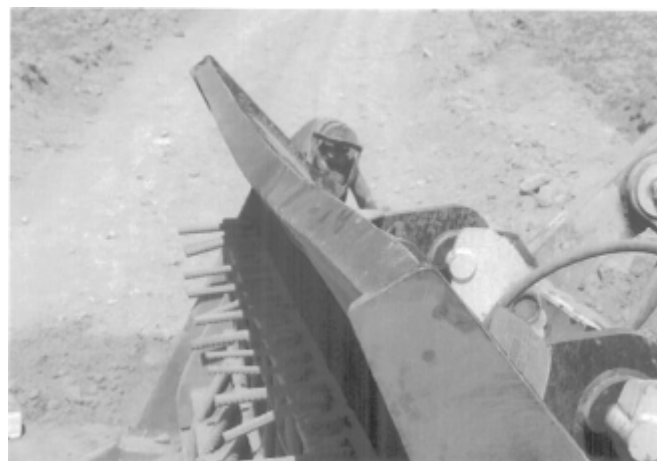
3.3.2. The mole board was bent back about 5 cm out of true:

3.3.3. Two small welds were broken: one attaching the Gill system to the inside of the bucket (top left), and one attaching a lifting eye on the left side of the bucket.
