### DDASaccident456

# DDAS Accident Report

INVESTIGATION REPORT INTO MINE ACCIDENT WHICH OCCURRED ON 30 JULY 2002  
AT CMT MINEFIELD, PAILIN

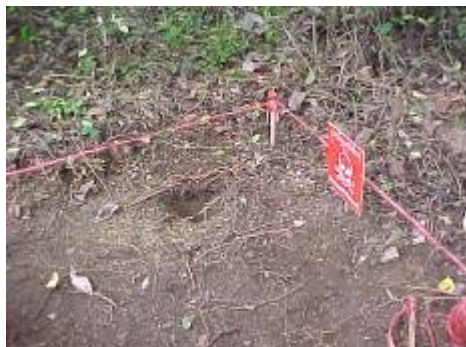
[The accident site]

The [Demining group] CMT Team had just commenced clearance operations at the hill top Pagoda site the same morning as the accident. Part of the team was clearing an area close to a stream bed at the bottom of the hill which has a lot of rocks and other vegetation. The immediate area above the site is very steep with loose metal.

Yes. A bulldozer has been used to level the top of the hill and has pushed gravel and stones down the sides of the hill. It is also an old Pagoda site so there is a lot of rubble around. A lot of bush exists at the base of the hill around the stream which also makes it very difficult to demine.

5. Based on the evidence, it is the inquiry teams opinion that the cause of the accident was that of a yet another deeply buried Type 72A mine, too deep to be detected and missed in the clearance of the lane.

**Recommendations**7. The investigation team after consideration of all factors makes the following recommendations:a. As with all previous investigations involving missed deeply buried Type 72A mines, [Demining group] must very quickly investigate either internally within [Demining group] or the Cambodian demining community or Internationally, to assist in helping seek a solution to this now [Demining group] wide problem. [Demining group] can ill afford to continue to hold off on finding a speedy solution or risk being held accountable for the mounting casualty rate.

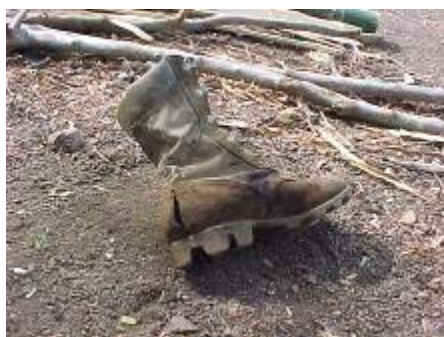
[The victim's boot.]

Based on the physical evidence, a missed deeply buried Type 72A Anti Personnel Mine.

The deminer suffered a blast injury to his left foot that later required amputation above the ankle.
