# DDASaccident456

# DDAS Accident Report

INVESTIGATION REPORT INTO MINE ACCIDENT WHICH OCCURRED ON 30 JULY 2002  
AT CMT MINEFIELD, PAILIN

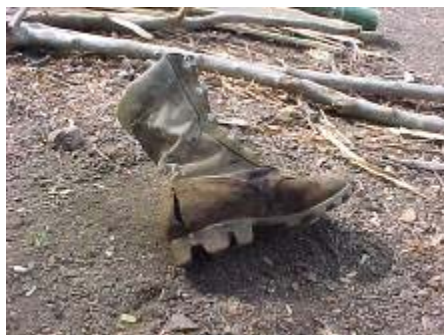
[The victim's boot.]

The deminer suffered a blast injury to his left foot that later required amputation above the ankle.
