DDAS Accident Report

Report date: 12/01/2008	Accident number: 468
Accident time: 06:30	Accident Date: 27/06/2007
Where it occurred: 1.5 km from Kirgochak, Rudaki District	Country: Tajikistan
Primary cause: Management/control inadequacy (?)	Secondary cause: Management/control inadequacy (?)
Class: Missed-mine accident	Date of main report: 04/07/2007
ID original source: TM07:01	Name of source: TMAC
Organisation: [Name removed]	
Mine/device: PMN AP blast	Ground condition: dry/dusty sandy
Date record created: 12/01/2008	Date last modified: 12/01/2008
No of victims: 1	No of documents: 2

REPORT OF BOARD OF INQUIRY INTO DEMINING ACCIDENT AT KIRGOCHAK ON 27
JUNE 2007

Dushanbe 04 July 2007

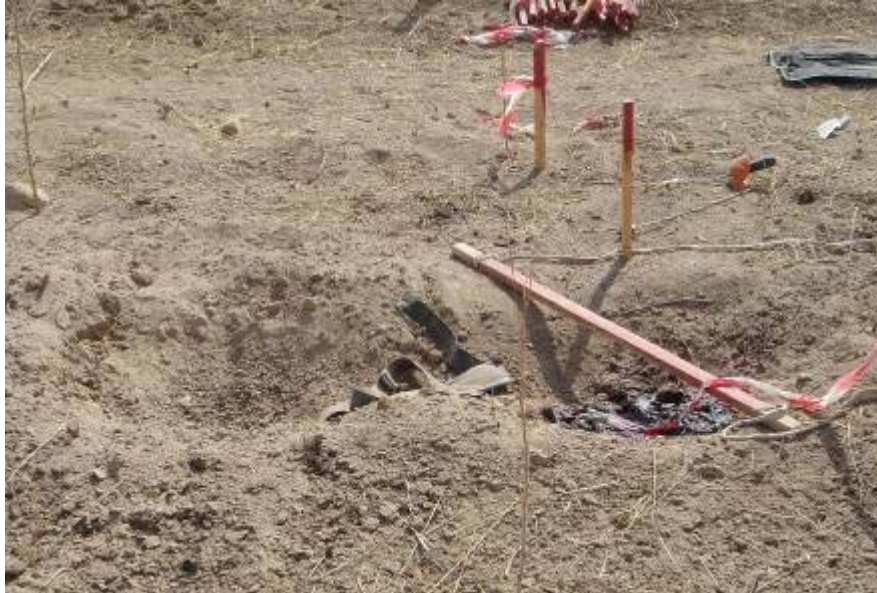
Accident site, [showing marking placed after the accident.]

Although the minefield is well marked, it was noted during the Board of Inquiry's investigations at the site, that the mine clearance site was not well marked. In particular, it was observed that insufficient marker pickets and marking tape had been deployed to show the line between cleared and uncleared areas. The area where [the Victim] was working was clearly the most potentially dangerous area on this part of the minefield, because he had a line of uncleared mines to his left, a line of craters created by recently destroyed mines to his right and a similar line behind him. In front of him there was a point where the line of craters stopped and continued as a line of uncleared, undiscovered mines. Despite this, there was no significant difference in marking here than at any other place on the minefield and marking to show where the line of cleared mines ended and where the uncleared area started was minimal.

12. Marking between cleared and uncleared areas should be improved. This is particularly important in areas where long lines of antipersonnel mines are being cleared by hand and multiple detonations of mines has occurred; it is difficult for deminers to see exactly where the end of the demolitions shot(s) finish and the uncleared mines lay. Demolitions supervisors should be fully aware of exactly how many detonations have occurred after every shot and how many detonators or charges have failed. The only way to be quite certain of this is to physically visit each crater to inspect whether the charge detonated as planned; therefore demolitions supervisors should count craters immediately after any demolitions task is completed and mark the end point of the tasking. In the case of Kirgochak minefield, where there is almost no vegetation and the mine rows are only a few metres from the barbed wire perimeter fence, this procedure can be carried out easily and without entering the dangerous or uncleared area.

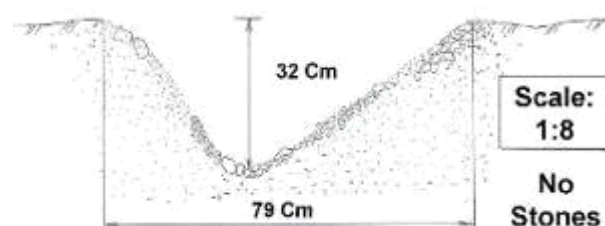
Analysis of the craters caused by the detonations shows that both of the mines involved in this accident were buried at a depth of approximately 12 centimetres in the ground and less than one metre apart. All PMN mines found by [Demining group] at Kirgochak so far have been buried at depths of less than 15 centimetres. Further evidence that mines at this task site are laid in shallow excavations may be deduced from the many uncleared mines which can be seen protruding from the surface of the ground. The mines were laid in the middle row of three rows. Mines were originally laid at this site by Russian armed forces in C1973 and the location was handed over to Tajikistan's Border Force in 2005.

Crater A [the crater he stepped in.]

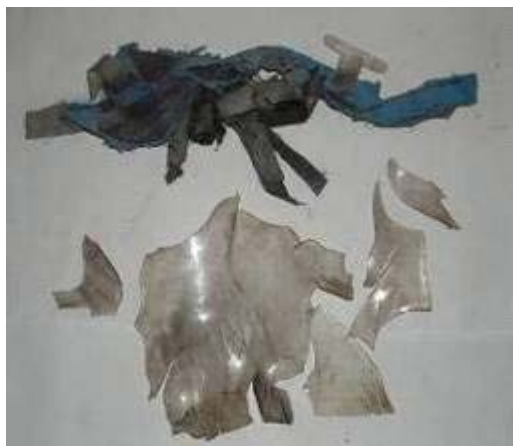
Visor. [The Victim]'s visor is severely deformed, broken and damaged by heat and blast. See images at Annex N [not included]. Close inspection of the largest piece of visor recovered after the accident showed enough side edges to determine its orientation. It is the lower part of the visor with the top edge entirely removed. The polycarbonate material was heat distorted, rippled and bubbled. It had been extensively thinned by stretching (from an original thickness of 5mm to 2mm) and heated to well above its forming temperature (at least 180 degrees Centigrade) throughout its thickness. A bottom corner had split and twisted inward, forming a sharp shard approximately 5cm long that pointed in towards the wearer's throat. The visor head-frame, made of ballistic aramid with a washable cover, had been shredded at the front. Visor damage is consistent with it receiving an extreme shattering force near the top centre and an extreme temperature for a microsecond. Fragments of the dark blue ballistic-aramid material used in the manufacture of the visor's head-frame were later found in the crater, (along with a small piece of burnt Bakelite, originally from the outer casing of the PMN mine and the remains of its striker-pin and spring).

The bottom of the visor is closest to the camera, heat bubbling and distortion is evident. The top of the visor is missing. Fragments of the head-frame material were found in the second crater.

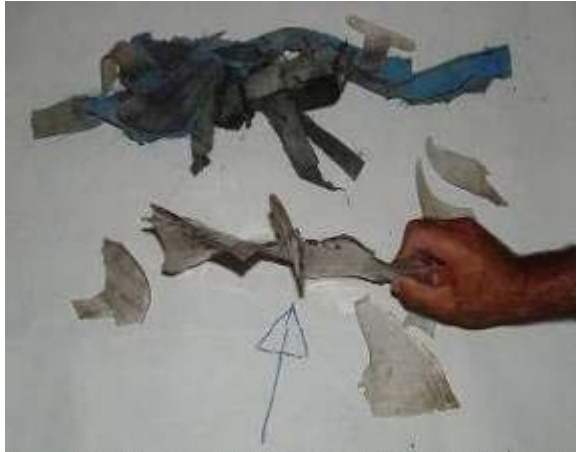
It seems probable that a mine was initiated by the wearer falling forward and striking the ground above a mine with the top part of the visor. The damage to the victim's throat is consistent with the sharp shard of visor on the lower edge being torn sideways as the visor was thrown away by the expanding blast wave.

Twisted spike at bottom of visor which injured the Victim's throat as it was torn aside.

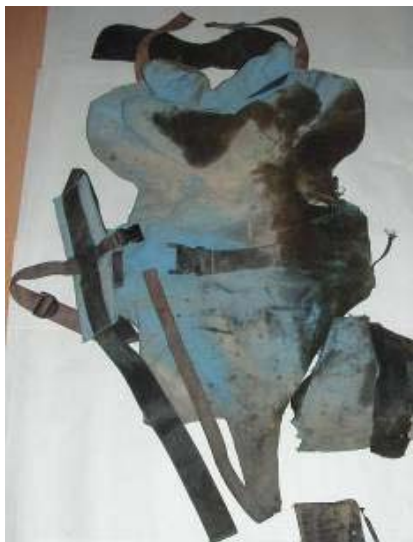
On inspecting the body armour, the damage was found to be concentrated on the left side, with panels torn away. This is consistent with the victim having stepped with his left foot on a mine while leaning forward. The front of the victim's left boot was missing and his shin (above if leaning forward) had been shattered. When reconstructing this position, the groin and genitals are directly above the seat of initiation and so inside the fragment cone associated with the detonation of a buried mine. The groin injuries are taken to confirm the victim's position.

What is inconsistent with the left-side frontal damage to the armour apron is the fact that the apron straps were torn from the apron (breaking nylon stitching), plastic buckles had snapped, and the apron was thrown 12 metres from the victim's body. The inner armour panel of the throat protection was also thrown aside, although its Velcro-fastened cover was undamaged. In the absence of other explanations it seems likely that the straps were broken and the collar emptied by a blast from above that entered behind the armour and sought to expand between the body and the armour, forcing the armour to break at its weakest points. When it broke, pressure behind it had built to the point that the armour was thrown aside and landed a distance away. A blast from above the armour neck-hole is consistent with the visor damage.

The Victim's PPE showing blast damage down the left side and straps torn off.
