# DDASaccident468

# DDAS Accident Report

REPORT OF BOARD OF INQUIRY INTO DEMINING ACCIDENT AT KIRGOCHAK ON 27  
JUNE 2007

Dushanbe 04 July 2007

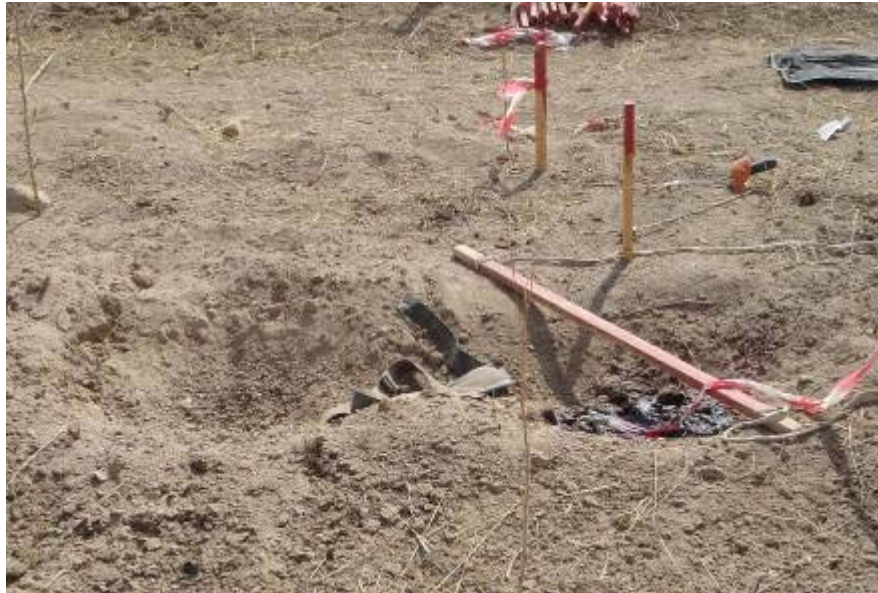
Accident site, [showing marking placed after the accident.]

Although the minefield is well marked, it was noted during the Board of Inquiry's investigations at the site, that the mine clearance site was not well marked. In particular, it was observed that insufficient marker pickets and marking tape had been deployed to show the line between cleared and uncleared areas. The area where [the Victim] was working was clearly the most potentially dangerous area on this part of the minefield, because he had a line of uncleared mines to his left, a line of craters created by recently destroyed mines to his right and a similar line behind him. In front of him there was a point where the line of craters stopped and continued as a line of uncleared, undiscovered mines. Despite this, there was no significant difference in marking here than at any other place on the minefield and marking to show where the line of cleared mines ended and where the uncleared area started was minimal.

12. Marking between cleared and uncleared areas should be improved. This is particularly important in areas where long lines of antipersonnel mines are being cleared by hand and multiple detonations of mines has occurred; it is difficult for deminers to see exactly where the end of the demolitions shot(s) finish and the uncleared mines lay. Demolitions supervisors should be fully aware of exactly how many detonations have occurred after every shot and how many detonators or charges have failed. The only way to be quite certain of this is to physically visit each crater to inspect whether the charge detonated as planned; therefore demolitions supervisors should count craters immediately after any demolitions task is completed and mark the end point of the tasking. In the case of Kirgochak minefield, where there is almost no vegetation and the mine rows are only a few metres from the barbed wire perimeter fence, this procedure can be carried out easily and without entering the dangerous or uncleared area.

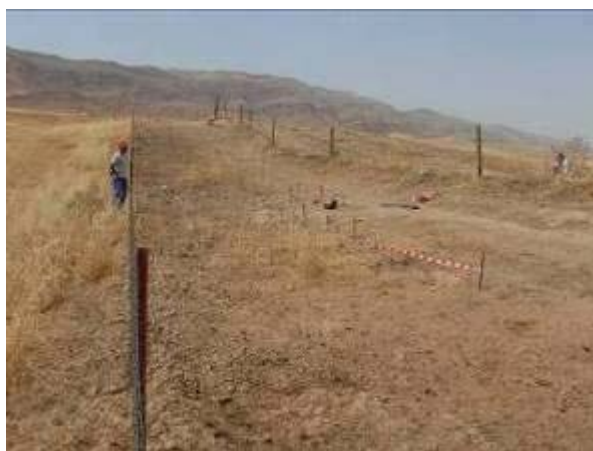
Perimeter Minefield Around an Ammunition Depot

The minefield is situated within a strip of ground, approximately ten metres wide and lined on each side by ten strands of barbed wire fence, suspended on angle-iron pickets, which are spaced at ten metre intervals around the minefield. It consists of three rows, each about two metres apart, of PMN antipersonnel landmines. Mines are spaced approximately 50cm to one metre apart, and the rows continue all around the entire perimeter of the ammunition storage depot.

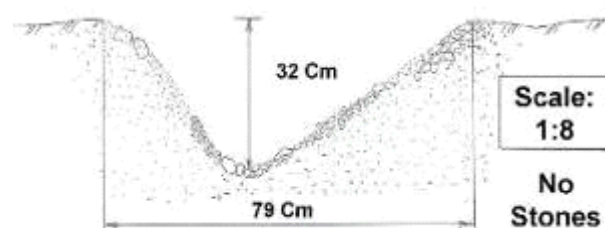
Analysis of the craters caused by the detonations shows that both of the mines involved in this accident were buried at a depth of approximately 12 centimetres in the ground and less than one metre apart. All PMN mines found by [Demining group] at Kirgochak so far have been buried at depths of less than 15 centimetres. Further evidence that mines at this task site are laid in shallow excavations may be deduced from the many uncleared mines which can be seen protruding from the surface of the ground. The mines were laid in the middle row of three rows. Mines were originally laid at this site by Russian armed forces in C1973 and the location was handed over to Tajikistan's Border Force in 2005.

Crater A [the crater he stepped in.]

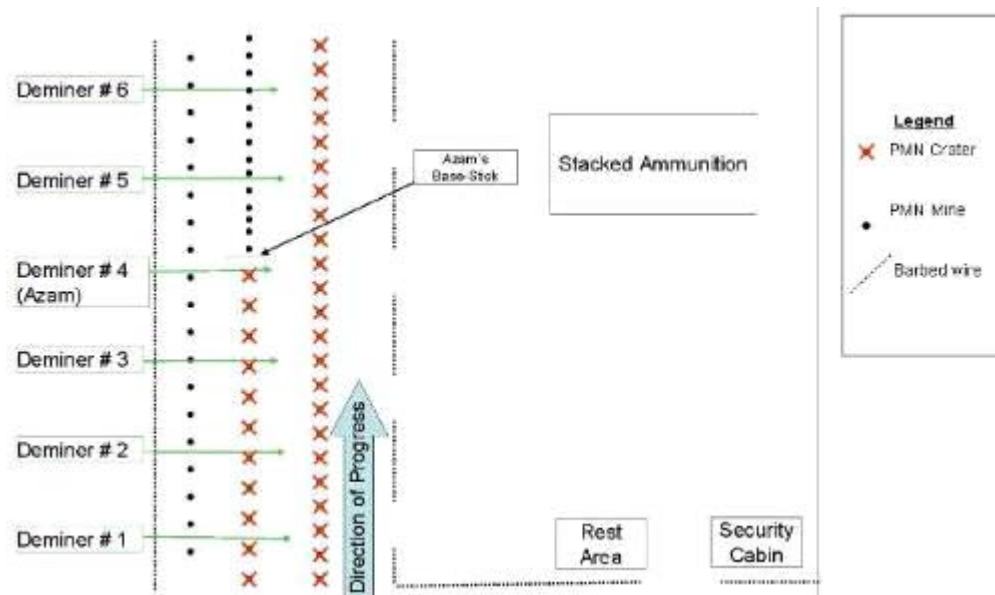
Each deminer was separated from his nearest co-worker by a distance of approximately twenty-five metres, as shown in the diagram below. Each deminer was responsible for the clearance of the ground between his own position and the position where the next deminer was working in front of him.

[The Victim] deployed to the middle part of this line of workers, with three deminers in front of him, each spaced at twenty-five metre intervals apart from the next, and three deminers behind him at similar spacing.

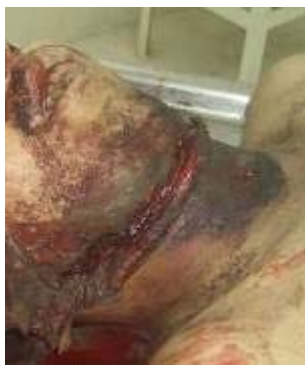
- f) A large part of the visor became a very fast moving projectile and cut through [the Victim]'s neck at extremely high speed. This injury quickly caused the loss of a considerable amount of blood from the front and right side of [the Victim]'s neck.

Throat injury

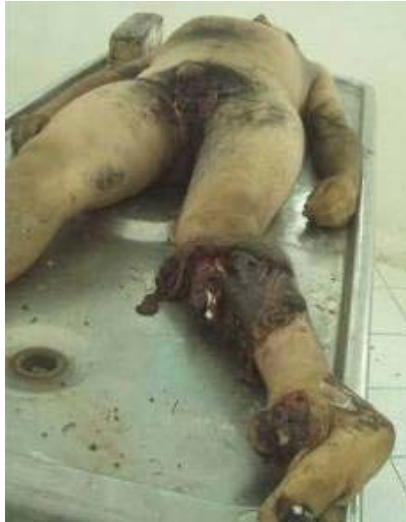
All lower body injuries.

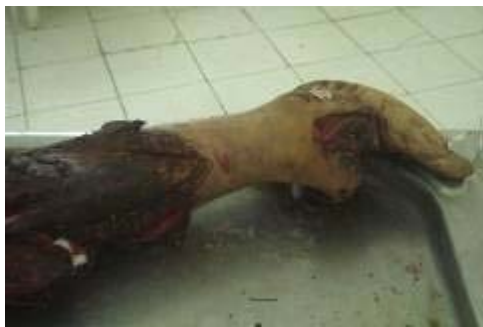
Remains of foot

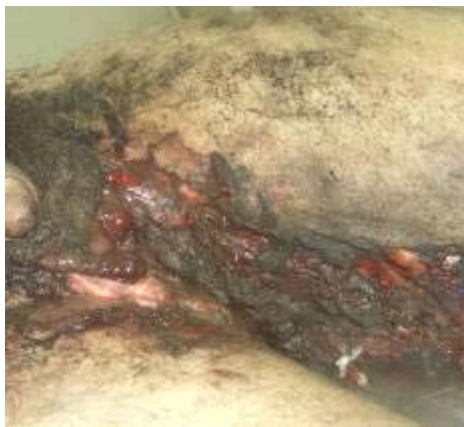
Upper inner thigh and genital injury.

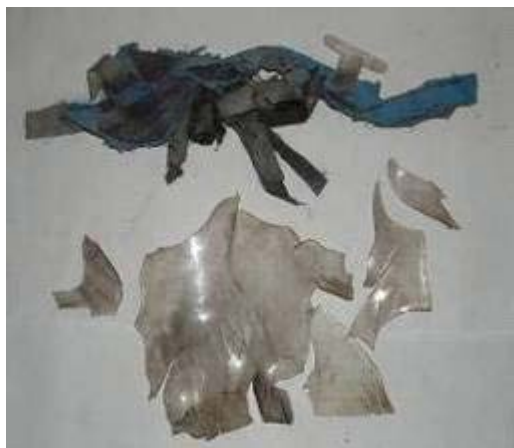
**Visor.** [The Victim]'s visor is severely deformed, broken and damaged by heat and blast. See images at Annex N [not included]. Close inspection of the largest piece of visor recovered after the accident showed enough side edges to determine its orientation. It is the lower part of the visor with the top edge entirely removed. The polycarbonate material was heat distorted, rippled and bubbled. It had been extensively thinned by stretching (from an original thickness of 5mm to 2mm) and heated to well above its forming temperature (at least 180 degrees Centigrade) throughout its thickness. A bottom corner had split and twisted inward, forming a sharp shard approximately 5cm long that pointed in towards the wearer's throat. The visor head-frame, made of ballistic aramid with a washable cover, had been shredded at the front. Visor damage is consistent with it receiving an extreme shattering force near the top centre and an extreme temperature for a microsecond. Fragments of the dark blue ballistic-aramid material used in the manufacture of the visor's head-frame were later found in the crater, (along with a small piece of burnt Bakelite, originally from the outer casing of the PMN mine and the remains of its striker-pin and spring).

The bottom of the visor is closest to the camera, heat bubbling and distortion is evident. The top of the visor is missing. Fragments of the head-frame material were found in the second crater.

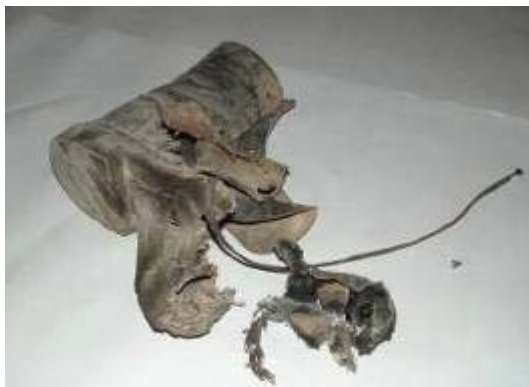
The victim's left boot.
