DDASaccident469

DDAS Accident Report

ACCIDENT INVESTIGATION FOR [Demining group] – MINE ACTION TEAM - JORDAN
ISRAELI MINEFIELD NO. (69270030), SOUTH SECTOR AQABA, WADI ARABA
GRID REF: N 34.978161: E 29.573281: 1 JULY 2007

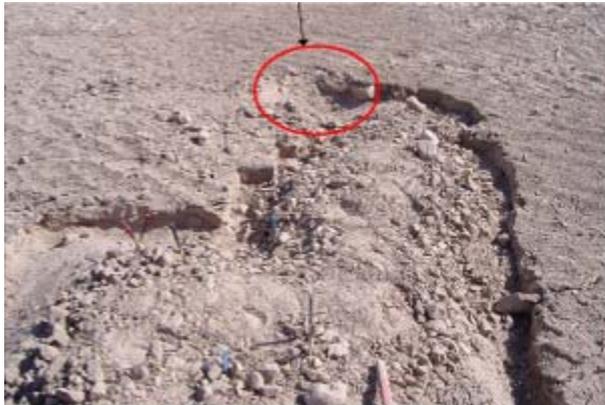
Mine Blast Location

The mine that was involved in the accident was a M35 Belgium AP (Blast) Mine, on the surface, discovered by Raking with a Heavy rake. The crater depth was approx. 15cm. the width was approx. 30cm.

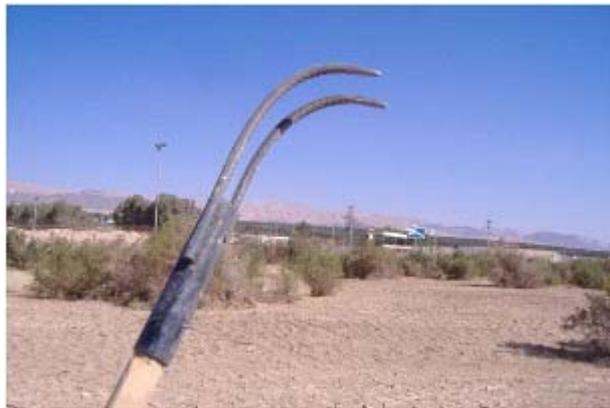
Heavy Rake head

[The tines of this heavy rake are not curved enough: they bend with protracted use. This may have occurred in the mine blast. The error was corrected.]

The primary and secondary causes of this accident are listed as "Unavoidable" because the hard crust on the ground surface could only be broken by using force. In this case, that force was enough to detonate the mine. The demining group had put in place the use of a long tool (rake) that kept the Victim far enough away from a blast to avoid injury, and his PPE was effective at protecting him from any risk remaining at that distance. Had he been using conventional short hand-tools, some injury would have been expected.

This demining group acknowledge the fact that stand-off (distance from the detonation) is the most effective PPE and their Rake Excavation system makes use of this. It is possible that the extreme length of the tool makes initiation of small AP blast mines with the Heavy rake more likely, but any increased risk of initiation is offset by the reduced chance of that initiation resulting in injury. The accident is a good example of balancing an effective demining process and PPE to result in a very low risk of injury.
