# DDASaccident470

# DDAS Accident Report

ACCIDENT INVESTIGATION FOR [Demining group] – MINE ACTION TEAM – JORDAN,  
Israeli Mf No. 71390029, WADI ARABA, NORTH NORTH SECTOR, GRAYGRA  
GRID REF: N 30.6665: E 35.2672  
4 SEPTEMBER 2007

## **IMAS DETAILED REPORT FOR MINE INCIDENT TUESDAY, 4 SEPTEMBER 2007**

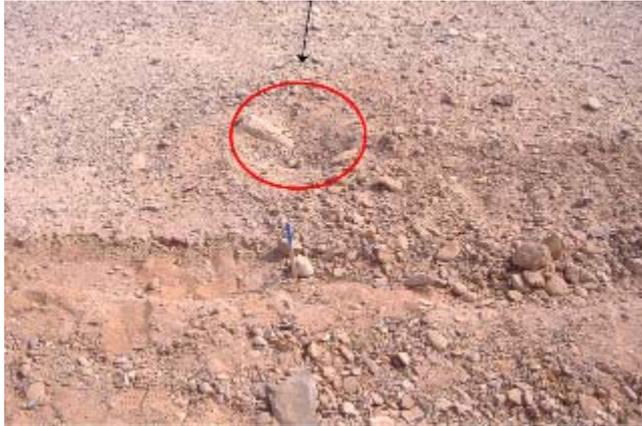
Mine Blast Location

Device detonated while raking with Heavy rake.

The mine that was involved in the incident was an Israeli No-10 AP Mine. The resulting crater was Depth: approx. 20cm; Width: approx. 40cm.

- (a) The deminer is not followed the laid down drills.
- (b) The deminer violated the laid down drill, he has to clear only 50 cm in the front but he tried to remove the mines at a distance of 75 cm from the tray.
- (c) He has not approached the mines from the tray but he tried to remove the mine by loosening soil around the mine.
- (d) The Incident happened due to hacking on top of the mine.
- (e) The deminer has to be blamed for this incident.

The primary and secondary cause of this accident are listed as "Unavoidable" because the hard crust on the ground surface could only be broken by using force. In this case, that force was enough to detonate the mine. It is possible that Victim was also breaching rules by "over-reaching" but the Operations Officer responded by dismissing him from service, which implies that appropriate corrective measures were being made to ensure that the procedures are generally conducted safely. The demining group had put in place the use of a long tool (rake) that kept the Victim far enough away from a blast to avoid injury, and his PPE was effective at protecting him from any risk remaining at that distance. Had he been using conventional short hand-tools, some injury would have been expected.

It is recommended that this kind of violation of the safety rules and drills should not be tolerated. Those who are failing to adhere to the rules should be given severe punishments. The deminer should be dismissed immediately.
