DDASaccident475

DDAS Accident Report

Report date: 15/01/2008	Accident number: 475
Accident time: 06:55	Accident Date: 26/08/2006
Where it occurred: MF No. 004, North South Sector, Beyr Mathkour, Wadi Araba	Country: Jordan
Primary cause: Field control inadequacy (?)	Secondary cause: Inadequate training (?)
Class: Excavation accident	Date of main report: 28/08/2006
ID original source: NS-10-05/26/08/06	Name of source: JES
Organisation: [Name removed]	
Mine/device: No 10 AP blast	Ground condition: dry/dusty hard sandy
Date record created: 15/01/2008	Date last modified: 15/01/2008
No of victims: 1	No of documents: 2

OF MINE INCIDENT AT BEYR MATHKOUR

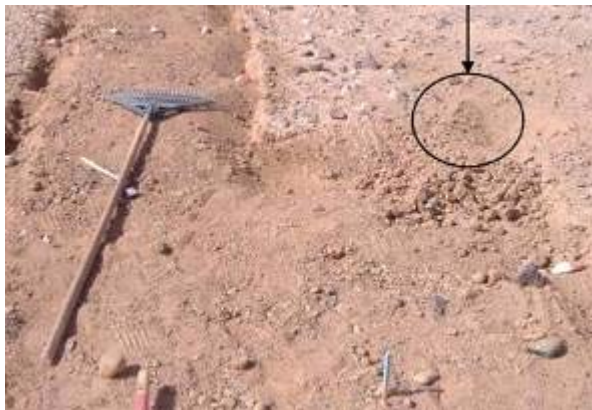
The crater depth was approx. 18cm and its width approx 45cm.

[The position of the accident is circled below.]

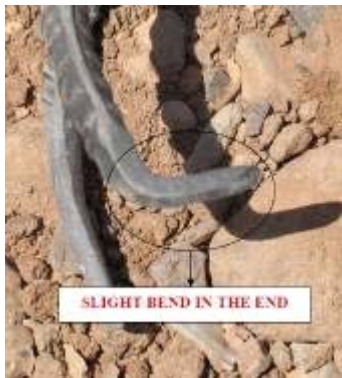
List equipment/facilities/infrastructure damaged: Heavy Rake slightly bended

[One rake tine was bent, but not broken or burned.]

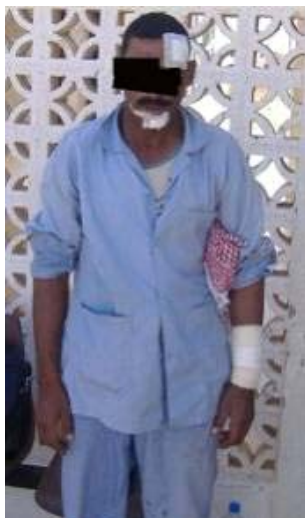
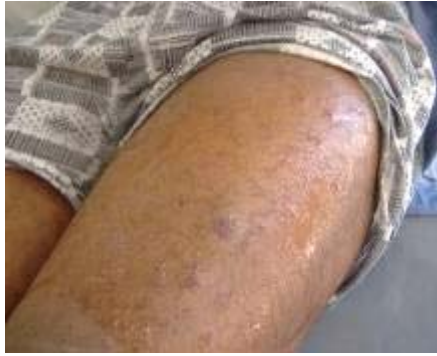
"Three superficial wounds left lower arm, left femur, left side of his forehead and left side of his chin.

Pictures below show very light injuries.
