DDASaccident476

Humanitarian Demining Accident and Incident Database

DDAS Accident Report

Report date: 15/01/2008	Accident number: 476
Accident time: 11:40	Accident Date: 16/07/2006
Where it occurred: MF No.006, Beyr Mathkour Village, North South Sector, Wadi Araba Province	Country: Jordan
Primary cause: Field control inadequacy (?)	Secondary cause: Inadequate training (?)
Class: Excavation accident	Date of main report: 25/07/2006
ID original source: MF No.00616/07/06	Name of source: JES
Organisation: [Name removed]	
Mine/device: No 10 AP blast	Ground condition: dry/dusty hard sandy
Date record created: 15/01/2008	Date last modified: 15/01/2008
No of victims: 1	No of documents: 2

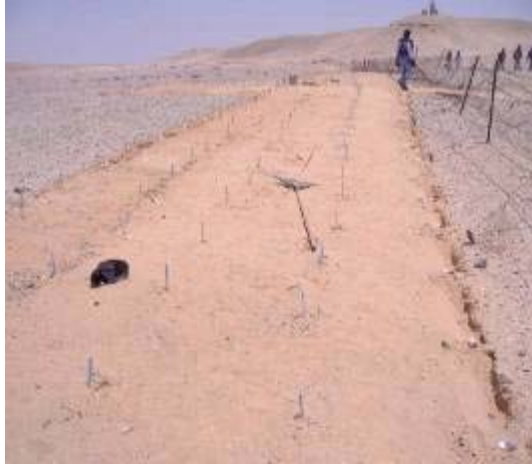
[The accident site is shown below. The blue sticks mark the positions of recovered mines.]

The crater depth was approx 15cm and its width approx. 30cm.

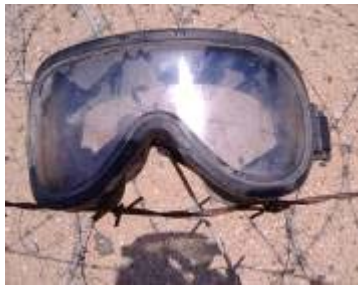
The deminer had been working that day for four hours before the accident. He was wearing a protective Vest and Goggles [goggles worn on forehead].

[The undamaged goggles are shown below.]

The Team leaders and section commanders have to ensure that all deminers should wear the goggles while working inside the minefield. Anybody violating the rule should be suspended immediately without delay.

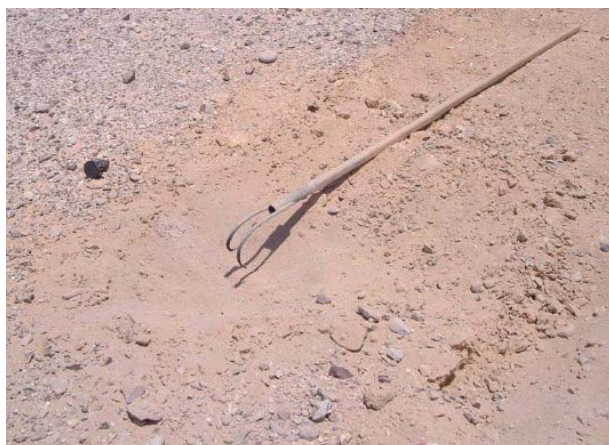
A mine blast incident occurred at approximately 11:40hrs on Sunday 16/07/2006 in the lane No-6. Deminer [the Victim] detonated a No-10 Israeli anti personnel blast mine. At the time of the incident the deminer was wearing the PPE but the goggles were on his forehead. The deminer turned his head towards back side and asking time from the other deminer who his working behind him. The deminer was not focussing on his work and hit the mine on the top by heavy rake resulted in a mine blast. The deminer sustained minor injury in his right arm and eyes fill with mud [dust/earth].

[The crater and the rake in use are shown below.]

The demining group had put in place the use of a long tool (rake) that kept the Victim far enough away from a blast to avoid serious injury, but he was still lucky to have turned his head and so moved his eyes from the most vulnerable position. His light arm injury may have been caused by the rough wooden handle of the rake. Of course, if he had been watching what he was doing he might not have initiated the mine. The raking process that this demining group has pioneered is only safe if systematically conducted in a disciplined manner. As with any tool, rakes can be misused. The most common misuse is "Hacking" at hard ground with the Heavy rakes, which this man did. The distance still provided some protection and probably prevented a more severe facial injury.
