### DDASaccident477

# DDAS Accident Report

<b>Report date:</b> 17/01/2008	<b>Accident number:</b> 477
<b>Accident time:</b> 07:39	<b>Accident Date:</b> 14/08/2006
<b>Where it occurred:</b> MF ID: NS-10-16, Beyr Mathkour, Wadi Araba	<b>Country:</b> Jordan
<b>Primary cause:</b> Field control inadequacy (?)	<b>Secondary cause:</b> Unavoidable (?)
<b>Class:</b> Excavation accident	<b>Date of main report:</b> 14/08/2006
<b>ID original source:</b> NO10/16:14/08/06	<b>Name of source:</b> JES
<b>Organisation:</b> [Name removed]	
<b>Mine/device:</b> No 10 AP blast	<b>Ground condition:</b> dry/dusty hard
<b>Date record created:</b> 17/01/2008	<b>Date last modified:</b> 17/01/2008
<b>No of victims:</b> 1	<b>No of documents:</b> 1

MINEFIELD TASK ID - NS - 10 - 16

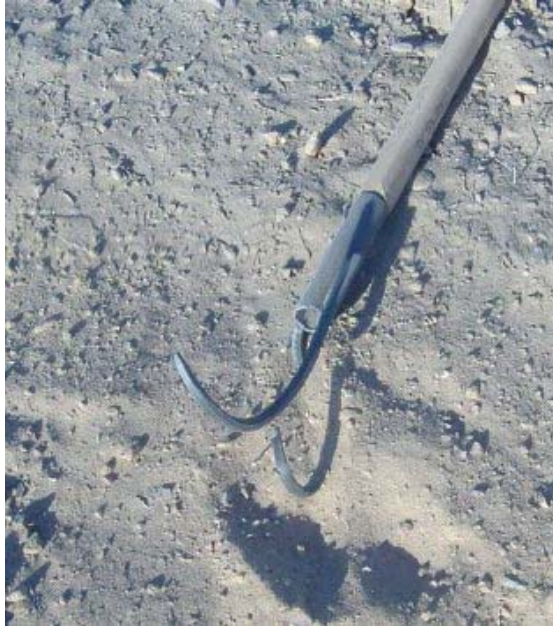
A [Demining group] Manual Team One, deminer hit a No.10 AP mine from the top that resulted in a mine blast. The deminer suffered no injuries. He was wearing his protective Vest and Goggles. [Photographs of both Victim and PPE showed no damage.] The tines of the heavy rake were bent.

The primary cause of this accident is listed as a "Field control inadequacy" because the photographs show that the initiation occurred outside the lane (marking is achieved by side of lane trenches) on ground that had not been "brushed" with the Light rake. In the correct procedure, the Light rake is used before the Heavy rake. It seems that Victim was working in a manner that conflicted with authorised procedures and his mistake was not corrected. The secondary cause is listed as "Unavoidable" because there is not enough information in the report to be certain of the cause, and the deminer may not have been at fault.

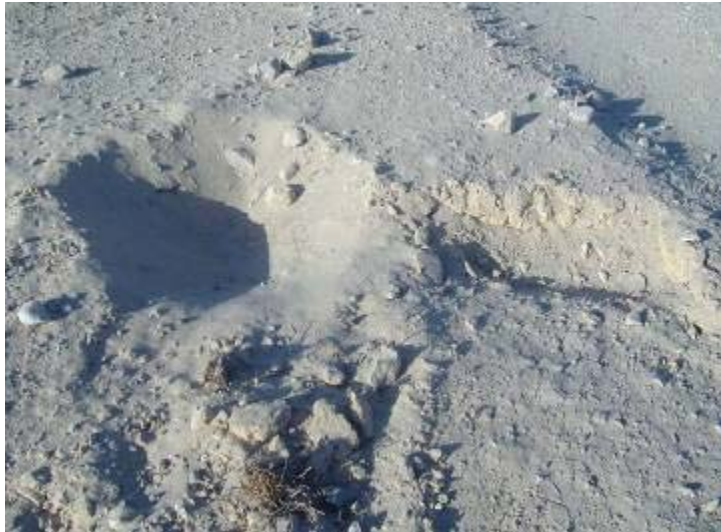
The crater left by the initiation was approx 15cm deep and 30cm wide.
