DDAS Accident Report

Report date: 29/04/2008	Accident number: 481
Accident time: 09:35	Accident Date: 19/04/2006
Where it occurred: Halkayor village, Panj district, Khatlon Region	Country: Tajikistan
Primary cause: Management/control inadequacy (?)	Secondary cause: Inadequate training (?)
Class: Other	Date of main report: 26/04/2006
ID original source: None	Name of source: TMAC
Organisation: [Name removed]	
Mine/device: PMN AP blast with ML-7	Ground condition: grass/grazing area hard rocks/stones
Date record created: 17/01/2008	Date last modified: 29/04/2008
No of victims: 2	No of documents: 2

BOARD OF INQUIRY INTO DEMINING ACCIDENT ON 19 APRIL 2006

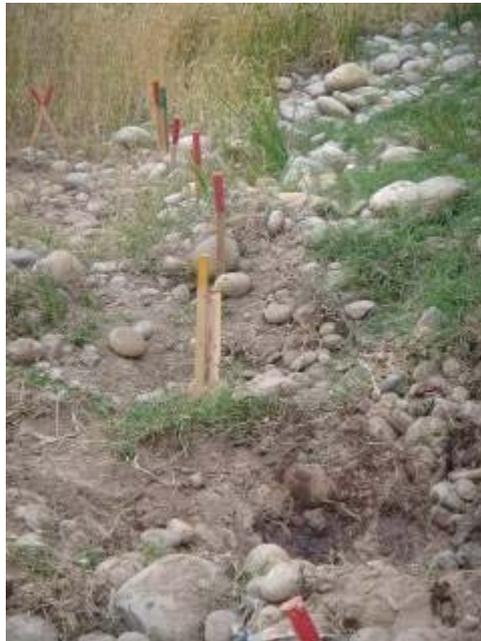
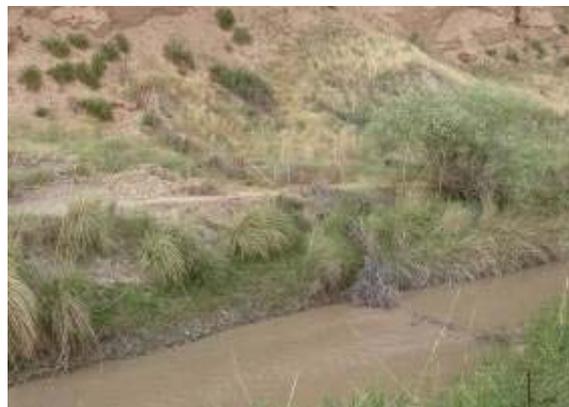
The pictures below show the accident site.

17. An unsurfaced track and an irrigation channel run parallel and next to each other, through the area. The track terminates next to a sluice gate in a dam, which may be used as a footbridge to access the minefield, situated next to the irrigation channel. The nearest

tarmac road is approximately 21 Kilometres away, at the town of Panj. The point where the mine detonated was approximately 50 metres from the unsurfaced track, to the north, or left-hand side of the track.

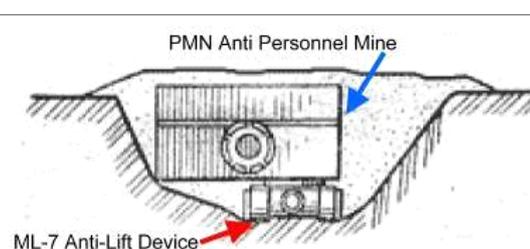
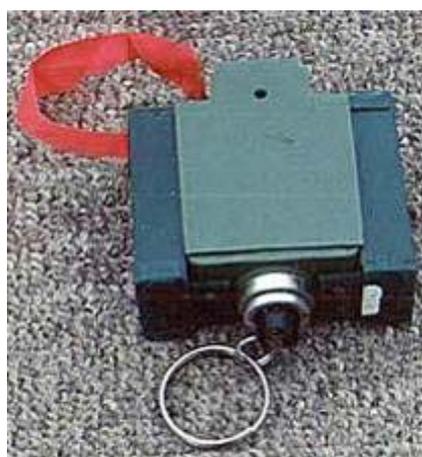
53. Fragments recovered from the crater created by the blast of the explosion show that the mine involved was a Russian PMN anti-personnel blast mine, coupled together with a ML-7 booby-trap switch. Crater left by the detonation is as would be expected from expected from such a device.
54. A PMN anti-personnel mine is loaded with 249 grams of high explosive. It is designed to be operated by 8 to 25Kg of pressure from above.
55. An ML-7 booby-trap switch is loaded with 40 grams of high explosive. It is designed to be operated by the removal of 4Kg pressure.

The minefield record handed over by the Russian army to the government of Tajikistan shows that PMN anti-personnel landmines had been laid by Russian armed forces within this area during November 1995. The area where the mine which detonated on 19 April is clearly illustrated on the minefield record as being within a minefield. See Annex E.

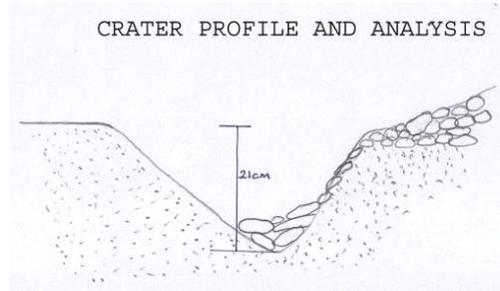
56. Analysis of the crater caused by the detonation shows that the mine involved in this accident was buried at a depth of approximately twenty-one centimetres in the ground. The mine was situated twenty-three centimetres inside the uncleared area, close to the marked clearance lane where a deminer was working at the time of the accident. See Annex K.

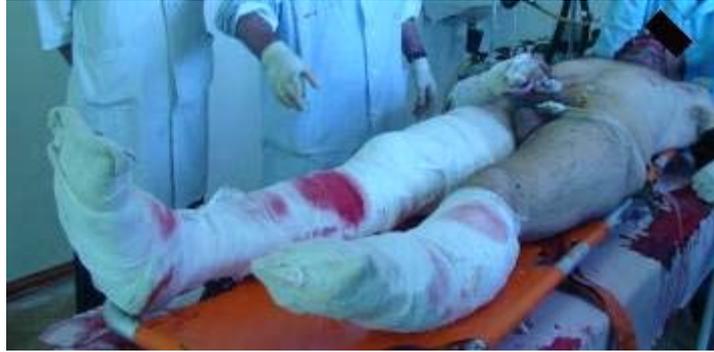
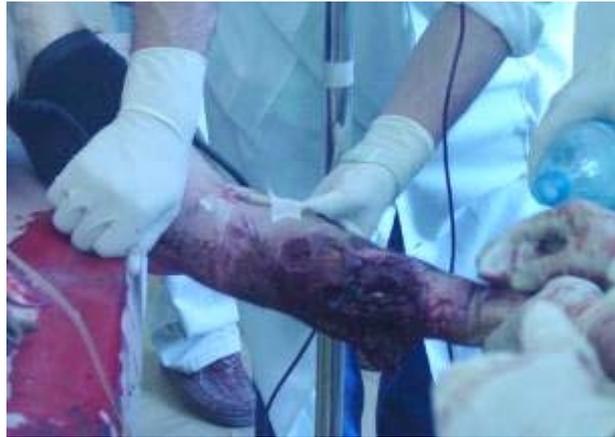
Mine explosion combined politrauma; Trauma amputation of the low 1/3 left shin; Open multi-fragmentation fracture of bones of the right shin and foot; Multi –fragmentation injuries close to shoulders and hands; Injury of the upper lip and cheek plus fracture of the upper right jaw; Multi –fragmentation injuries around the face, neck and chest. ZCh.MT.(not clear?). The brain got the severe injuries. Trauma shock type 4.

The following pictures were taken at the hospital.

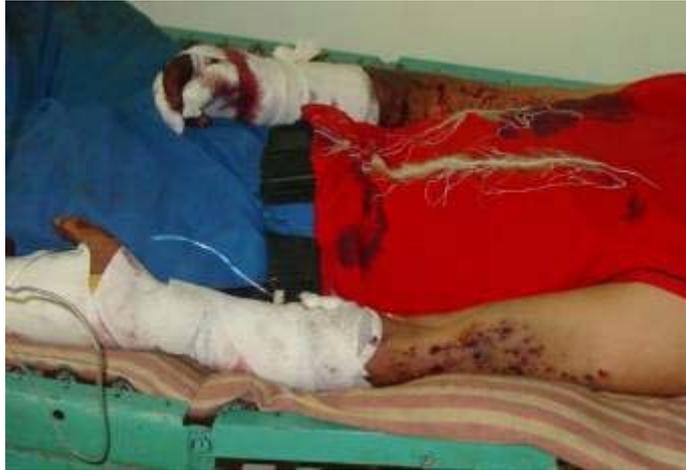
The victim “received injuries to his arms and hands. He was treated at Panj hospital within approximately one hour after the accident occurred and was evacuated by helicopter to Medgaradoc hospital in Dushanbe the same day.”

The following picture was taken at the hospital.

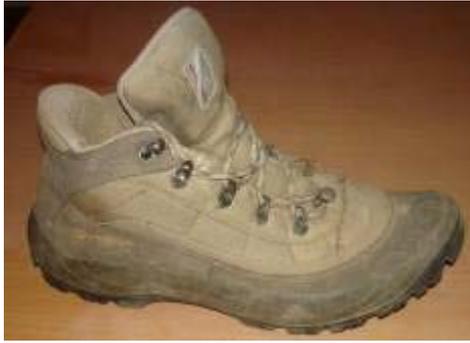
61. At the time of the explosion, [Victim No.1] was wearing lightweight hiking boots, as shown in the image at Annex M. The right boot was severely and extensively damaged; the sole was cut and a large part of the boot's upper was ripped and frayed from the effects of the explosion as it was blasted away from his foot. The other boot has not so far been found and it is most likely that this was completely annihilated during the detonation which destroyed the lower part of [Victim No.1]'s left leg. [The second boot was later recovered entirely intact.]

Although it seemed at first that Victim No.1 must have deliberately entered the minefield, a subsequent discovery throws doubt onto that explanation. Months later, Victim No.1’s second boot was found further into the minefield – with no sign of damage. The only explanation for this is that it was not being worn at the time. It may be that Victim No.1 took off his shoe, perhaps to remove a stone, and stumbled into the mined area. Certainly he was at least 30cm inside the mined area and in a squatting or crouching position when he initiated the PMN, (boosted with an ML-7). If the boot was in his hand it could have been thrown aside by the blast. Close examination shows no damage

The second boot is shown below.

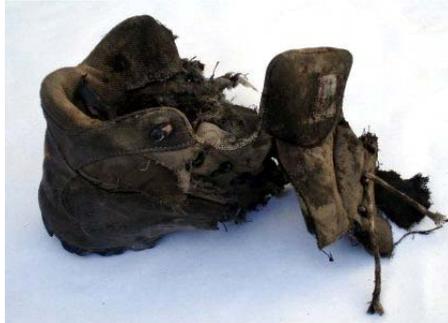
The first boot is shown below.
