## DDASaccident482

# DDAS Accident Report

## **REPORT OF BOARD OF INQUIRY**

INTO DEMINING ACCIDENT AT SHULL MOUNTAIN ON 21 AUGUST 2006

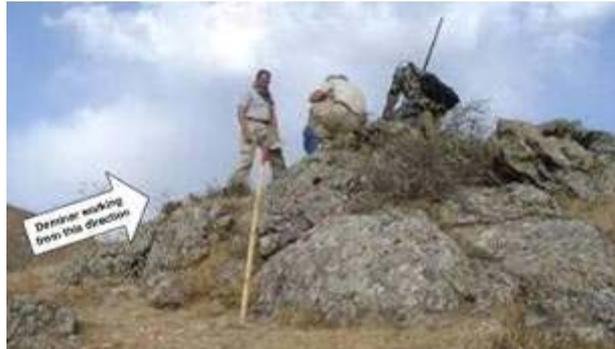
[The picture below shows the rocky outcrop where the accident occurred.]

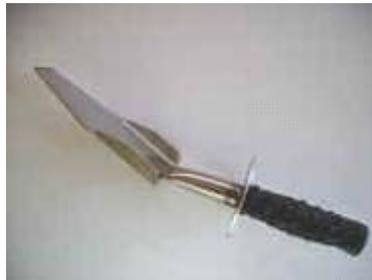
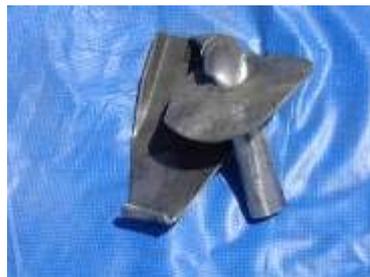
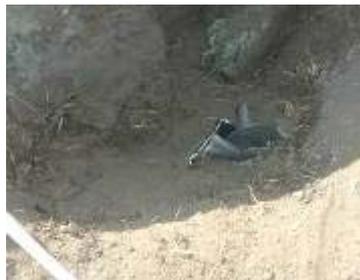
52. Prodder - A stainless steel prodder was found next to the crater and it was clear that, although ready for deployment, this tool was not in immediate use at the time when the mine detonated.
53. Pin hammer, normally used for driving wooden marker pickets into the ground. This was laid neatly on the ground, next to the manual prodder tool.
54. Trowel – A stainless steel, blast-resistant trowel, manufactured by LVP Technology of South Africa, (<http://www.lvptech.com/Main.htm>) was in the crater left by the blast of the mine. The trowel was severely damaged, the final 2cm of the point of the blade is rolled back on itself and the handle is bent completely over the blade.

[The trowel before and after the accident is shown below. This is sold as blast resistant because the material does not break. However, the length is not as recommended in IMAS, the metal handguard has broken and the handgrip has been removed in the blast.]

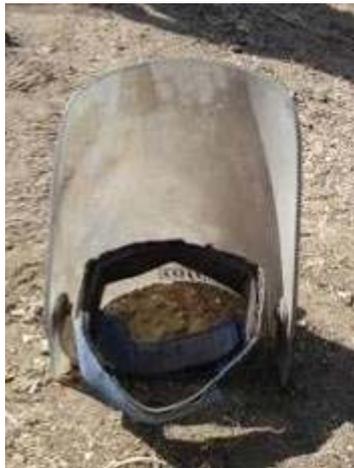
65. The blast resistant visor is the crux of this investigation. During the Board of Inquiry's time at the demining task site and the scene of the accident, a number of visors were observed by each member of the team. Some were in good condition, others were less so. If a visor is clear and clean and unmarked it is obviously easier to see through and there will obviously be less temptation for a deminer to lift his visor to attain a better view of his work or surroundings.

66. Protective facial visors are notoriously difficult to wear and deminers universally do not like to wear them. This is particularly the case in hot weather, when they can become fogged with condensation from the wearer's breath. When reasons for raising visors are given by deminers, they commonly make reference to a lack of optical clarity when looking through the visor. This may be blamed on light scratching, breath condensation, distracting optics (caused by reflections and refracted sunlight), airlessness and excessive heat. [The Victim's visor is shown below.]

67. There is sufficient damage inside the visor to suggest that it deflected environmental and mine-case fragmentation onto [the Victim's] face from the detonation of the PMN anti-personnel mine he was likely excavating at the time of the accident. From this it seems very likely that [the Victim] was using his trowel and excavating vertically over the mine with his visor at least partly raised.

- u) All personnel at all work sites should conform to all aspects of [International demining group]'s Standing Operational Procedures. Specifically, this should mean that, when they are working within hazardous areas, personnel deployed on mine clearance operations should wear PPE complete with visor in the fully down position to completely cover the wearer's face.

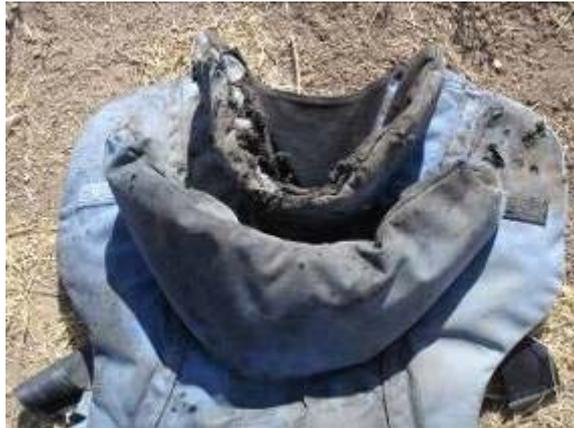
[Damage to the Victim's body armour makes it likely that a closed visor would have also sustained significant damage low down.]

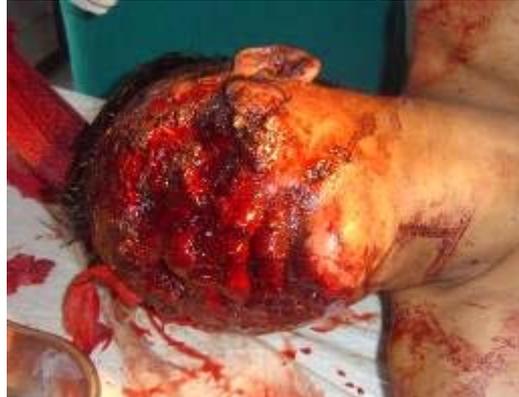
The pictures below show the Victim before and after surgery.

Photographs showed one leg bandaged top to bottom, the other peppered with small fragmentation wounds at the thigh. Both hands were bandaged and bloody with lacerations of the fingers.

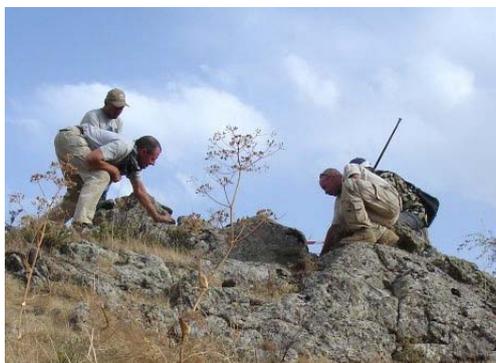
It is unfortunate that pictures of the accident investigation show International demining group expatriate investigators at the site wearing no PPE. This obviously sets a very bad example. They were inside a partly cleared minefield and – according to National standards and the demining group’s SOPs – should have been wearing PPE. The BoI investigators all wore PPE at the accident scene.

The International demining group investigators below are on the rocky outcrop where the accident occurred. The fact that they gave the picture to the BoI implies that they did not know that they were in breach of their own SOPs.
