DDAS Accident Report

Report date: 18/01/2008	Accident number: 483
Accident time: 09:50	Accident Date: 13/11/2007
Where it occurred: 1.5 km from Kirgochak, Rudaki District	Country: Tajikistan
Primary cause: Field control inadequacy (?)	Secondary cause: Management/control inadequacy (?)
Class: Handling accident	Date of main report: 20/11/2007
ID original source: None	Name of source: TMAC
Organisation: [Name removed]	
Mine/device: Fuze AP blast	Ground condition: not applicable
Date record created:	Date last modified: 18/01/2008
No of victims: 1	No of documents: 1

BOARD OF INQUIRY INTO DEMINING ACCIDENT

AT KIRGOCHAK ON 13 NOVEMBER 2007

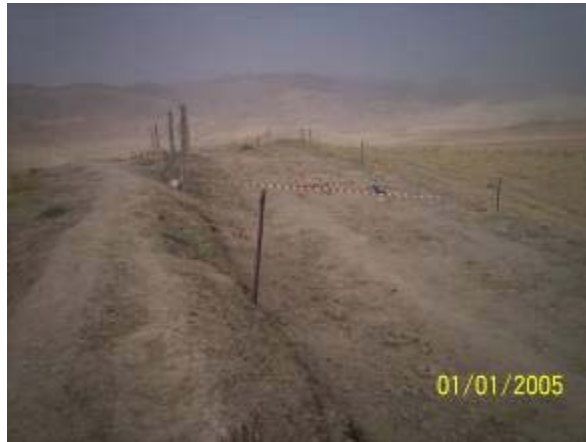
8. The general area where the accident occurred is grassy pastureland, wheat fields and rolling hills. The point of detonation was on an area of ground on a slight incline, at the distance of 13 m. from the minefield. [The picture below shows the general area.]

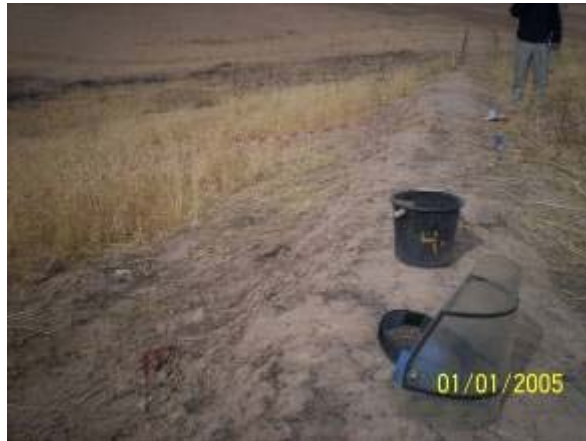
[The picture above shows the accident site.]
