# DDASaccident484

# DDAS Accident Report

DEMINEING ACCIDENT ON DEMINER OF [International demining NGO] AT BAGRAM

DATED 04 JUNE 2007

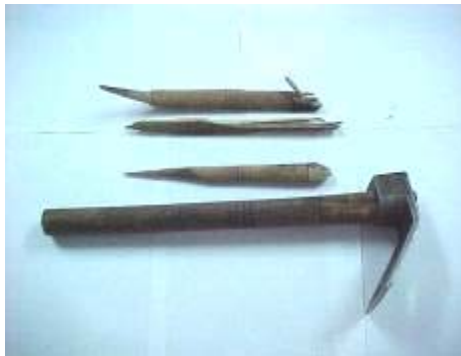
The trowel used by this International demining NGO may have been a short “mattock”, which they often call a “trowel” without explanation. Their mattock has featured in many accidents because it is difficult to use without considerable force. Its use is fast, but makes initiation more likely, especially of mines with pressure plates that extend over the entire top surface of the mine (as detailed in the GICHD Manual Demining Study 2005). From records in this database it can be seen that the mattock has caused severe injury when the head breaks off

and strikes the user. The deminer's arm loss in this accident may be a case in point. An example used by this International NGO in another country is shown below.

Alternatively, the tool may have been some kind of builder's trowel, which is also not a safe tool, breaking all of the design requirements for a blast resistant tool and failing to meet the recommendations in the IMAS. They are not designed for purpose, not designed to protect the user's hand and not designed to stay in one piece in a blast.

The primary cause of this accident is listed as "Inadequate equipment" because the inappropriate design of tools makes initiation more likely. The fact that this has been known for many years but not recognised by the management of the International demining NGO involved in this accident is the reason that the secondary cause is listed as a "Management control inadequacy". The NGO's failure to ensure that the field supervisors enforced the correct wearing of the visor is another management control inadequacy.
