# DDASaccident485

# DDAS Accident Report

## Demining Investigation Report

DEMINING ACCIDENT ON DEMINER OF [International demining NGO] AT KOH-E-SAFI

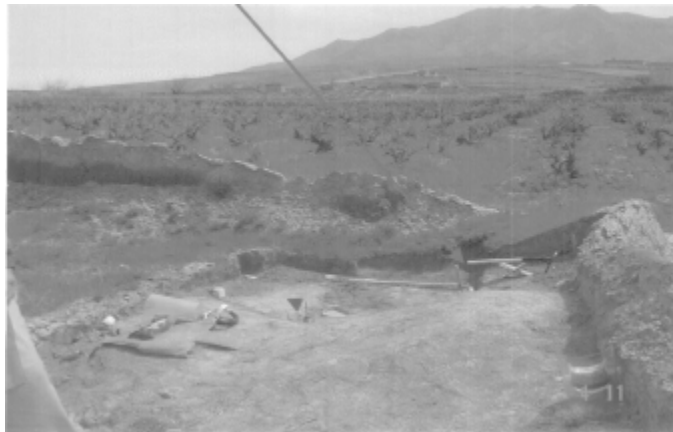
[The accident site, showing the mud-brick wall that has collapsed at the accident place.]

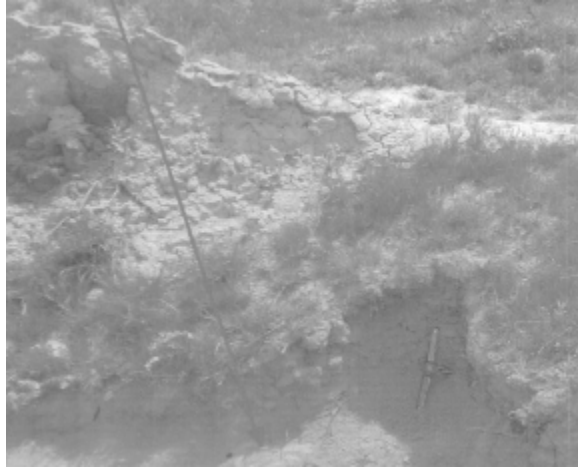
3. The accident has occurred near corner of a ruined mud wall, the mud of the wall has gradually huddled on the ground surface as its height reached to 40 cm at the accident point, the deminer has failed to firstly remove this soil from original surface of the ground then consider the 15 cm depth from original surface of this area.

[The picture below shows the accident site and the depth of the collapsed wall.]

a) The accident has happened near the corner of a ruined muddy wall as because of timeworn, wetness the mud gradually poured down and reached to 40 cm at the accident point. The deminer has failed to firstly remove this soil and then address the original surface of the ground with 15 cm depth.

1. Whenever the deminers are working on an area on which sediment soils have been gathered, they must firstly remove the sediment soils from the original ground surface then consider 15 cm depth.

a) Whenever deminers work in areas, on which sediment soil exist, they must firstly remove the extra soil systematically and safely in layers and after the original surface is appeared then 15 cm depth to be considered.

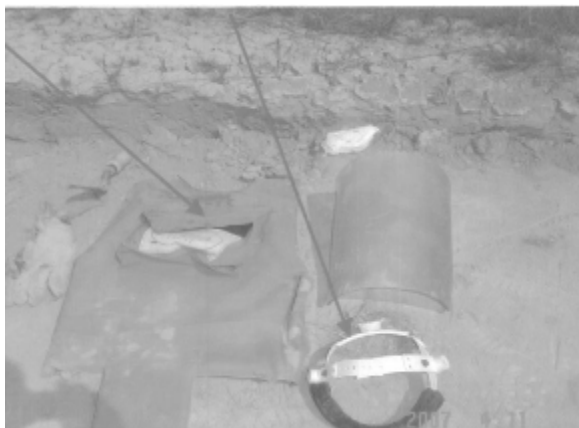
Description of damage to property: 1. Visor belt has been disconnected from the visor; 2. Cover of the PPE vest was torn.

[The torn cover of the PPE vest and broken plastic head-frame of the visor. The trowel is top left. It is a large plasterer's trowel, mild steel with wooden handle. The photograph is unclear, but it seems to be broken.]

The builder's trowel used by this Victim is not a safe tool, breaking all of the design requirements for a blast resistant tool.
