# DDASaccident486

# DDAS Accident Report

## IMSMA Demining Investigation Report

Report dated 30th November 2006

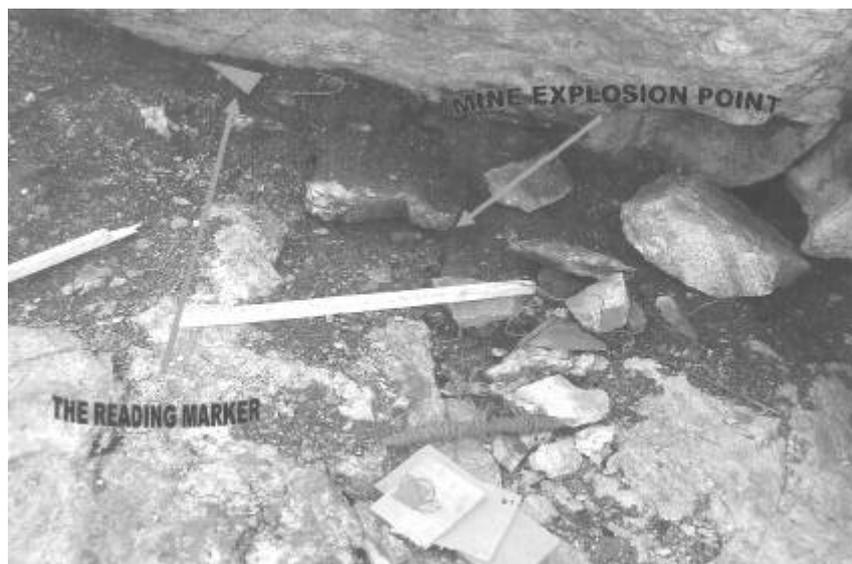
[The accident site is shown below.]

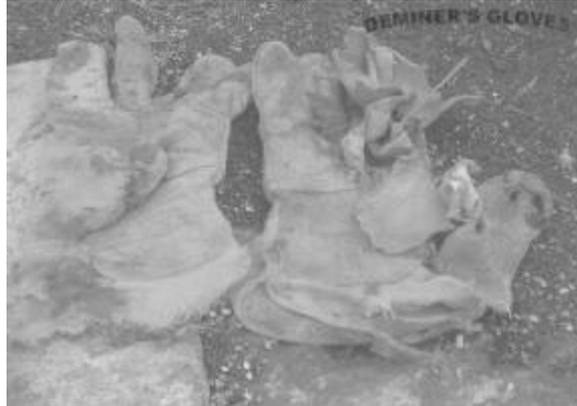
Description of equipment damage: The scraper, Visor, PPE Wooden Stick, trowel, Stand of the detector and the gloves had got damaged.

[The Victim's gloves are shown below. The damage to them, and the blood on the body armour (photo reproduced elsewhere) imply that the injuries may have been more severe than the demining group acknowledged.]

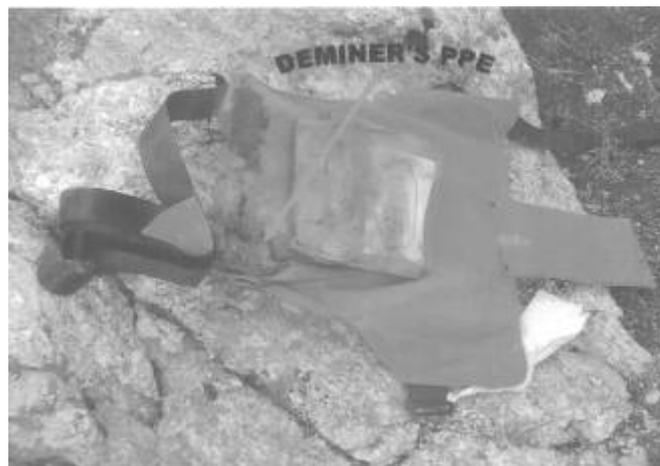
[The victim’s PPE with no collar to interface with the visor is shown below. There are blood stains at the top.]

With the minimal frontal vest favoured by this demining group, there is nothing to prevent blast debris entering below the visor. This vest and visor does not meet the IMAS and is unsafe. This International NGO’s deminers frequently suffer facial injury and eye loss. This should have made them reconsider their protection years ago.

In this instance, it is probable that the visor was also worn raised because the Victim suffered a nose injury that appears to have bled significantly.
